Pile Integrity Testing To Determine Storm-Induced Damage

WILLIAM CAMP AND MOHAMED HUSSEIN

Hurricane Hugo made landfall in 1989 near Charleston, South Carolina, causing extensive damage. A pleasure boat marina was exposed to the full force of the storm. The marina consisted of concrete floating docks held in place by 14-in.-square prestressed concrete piles. The 42-ft-long piles had been driven 2 years before, and installation records were not available at the time of the testing (1990). The water depth was between 2 and 10 ft, and the soil conditions consisted of approximately 10 ft of soft mud overlying the Cooper Marl. During the storm, the surge floated the docks to nearly the pile tops and the extraordinary winds and waves pushed the large pleasure boats against the piles. After the storm, it was observed that some piles could be moved several inches laterally simply by pushing on them while standing on the docks, thereby causing the pile integrity to be questioned. Short on time for the new season, the owner was faced with a serious problem with potentially expensive remedies. Low-strain integrity testing performed on each of the 78 piles provided a timely and cost-effective

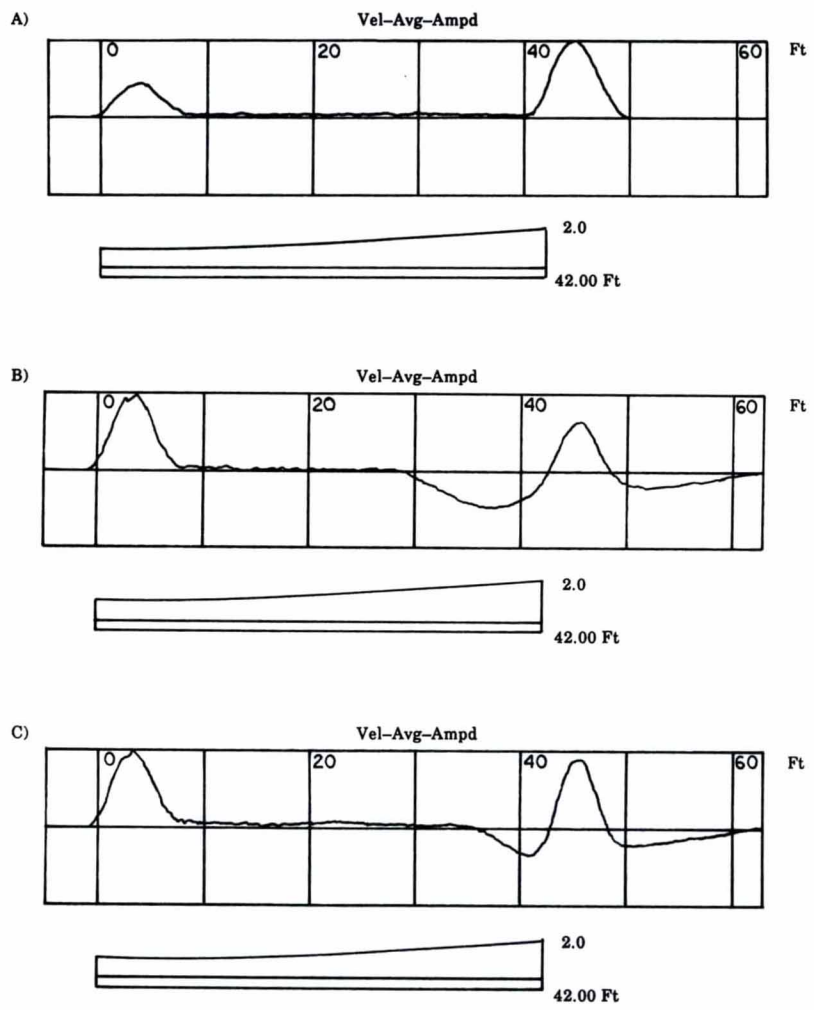
Assessments of structural pile integrity were based on the obtained records and their interpretation assuming a stress wave speed of 14.6 ft/msec. Typical data from apparently problem-free piles are shown in Figure 3. In general, the test records indicated that the piles were structurally sound. However, approximately half of the 78 piles had indications of possible minor cracks at roughly the pile midpoint. In making such interpretations, previous test results from two extracted piles lying on the ground were considered. One pile had a major crack 27 ft below the pile top. The record from this pile is shown in Figure 4. The pile was essentially broken but held together by the prestressing cables. The other pile had visible hairline cracks but no other apparent damage. Data from this pile were used as a control record. Pile records from the marina project were compared with this control record to aid interpretation. Such a comparison is shown in Figure 5, which includes the control record and typical records from piles with possible minor cracking.

FIGURE 3 Typical results from piles with no integrity problems.

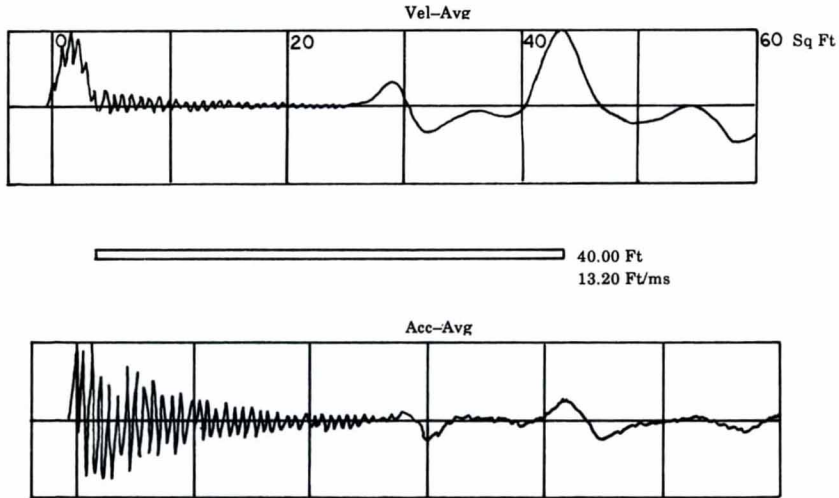
FIGURE 4 Extracted pile with major crack at 27 ft.

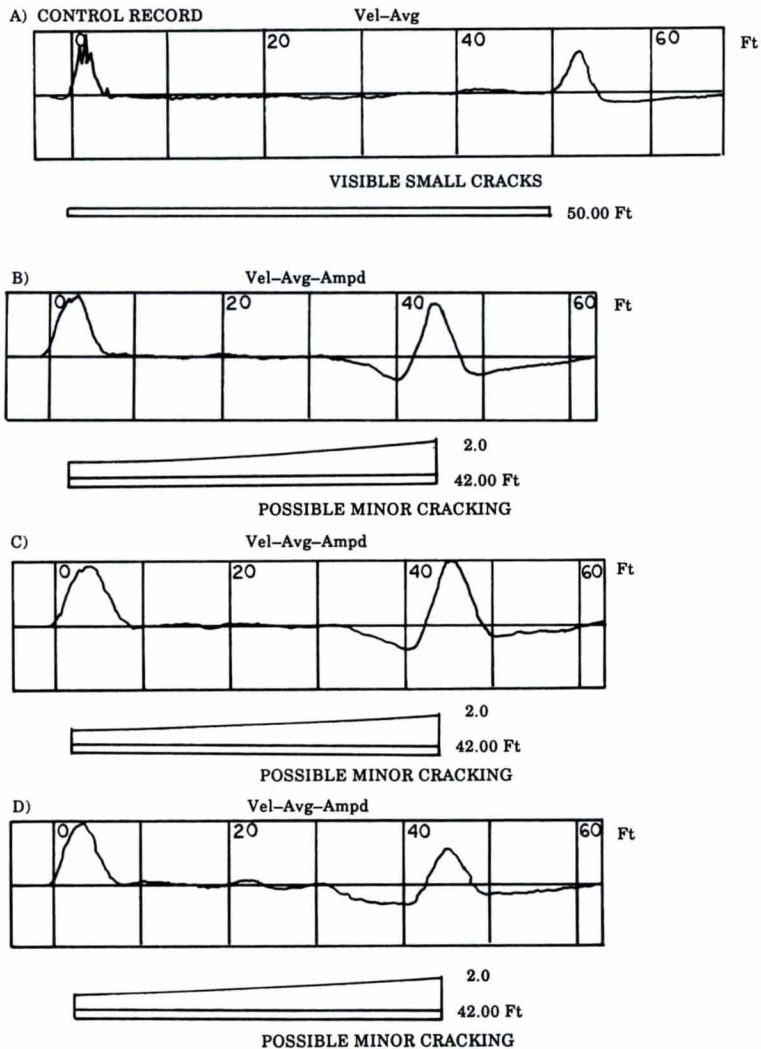
The client was informed that from a structural integrity standpoint, all piles were satisfactory. The tensile cracking may have been caused by the storm; however, the location of the cracking generally corresponded to the midpoint of the pile regardless of the depth at which frictional resistance first became apparent. Therefore, it was thought that the cracking had probably occurred during handling or installation of the pile rather than during the storm loading. It was noted that the zone of cracking was frequently above the mudline and in a highly corrosive environment. Consequently, the effect of the cracking on the long term integrity of a pile was unknown. Subsequent integrity testing over the lifetime of the marina could be used to monitor the suspect piles to determine whether significant corrosion was occurring. Because "baseline" records are already available, such an approach should be reliable.

FIGURE 5 Control record and typical records indicating possible minor cracking.

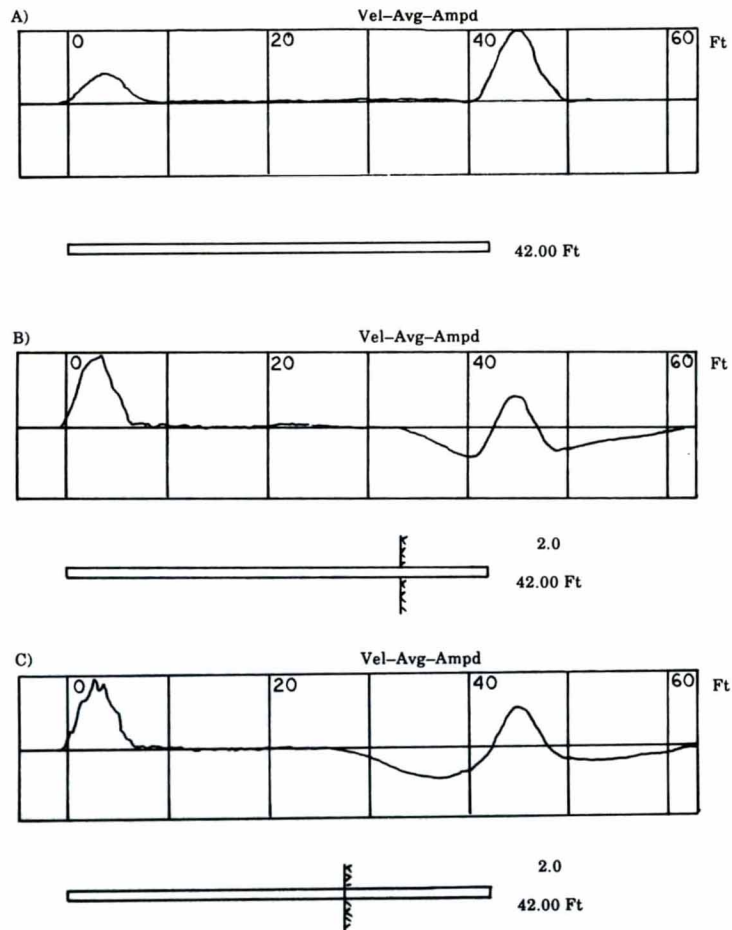
evidence of soil resistance (a relative decrease in velocity) beginning 7 to 14 ft above the pile toe. However, roughly 25 percent of the piles had very little frictional soil resistance. Figure 6 shows the difference between a pile with no apparent soil resistance and piles with resistance occurring at varying depths.

The apparent lack of soil resistance observed on many of the piles is thought to explain the relatively large lateral deflections that occurred, according to the marina personnel, under small loads. The lack of resistance could be a result of a lateral soil failure caused by excessive loading or erosion. Both possibilities could be related to the hurricane. The lack of resistance could also have been caused by design or construction errors. Regardless of the cause, it was recommended that the lateral capacity of the suspect piles be reevaluated

FIGURE 6 Typical records indicating varying amounts of soil resistance: A, no resistance; B, resistance below 34 ft; C, resistance below 28 ft.

through additional exploration and analysis and confirmed via lateral load testing.
