New Tete Bridge over the Zambezi in Mozambique

This article describes the use of CSL during the construction of the new Tete Bridge over the Zambezi River in Mozambique (Figure 1). CSL identified anomalies in two of the piles tested, PP1A and PP1D. These anomalies were evaluated to determine their depth, size and extent relative to the cross-section of the piles. Core samples were later obtained to confirm the existence of defects, and corrective action was taken.

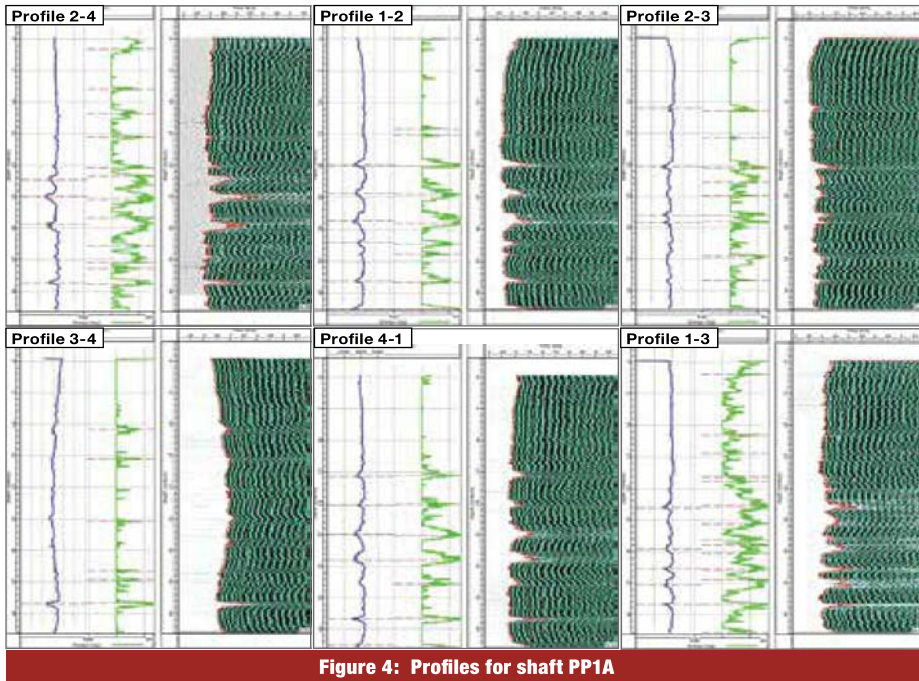
Figure 4: Profiles for shaft PP1A

CSL results revealed anomalies on piles PP1A and PP1D, as evidenced by Figures 4 and 5, which show significant energy and FAT decreases represented both on the processed results (left side) and waterfall diagrams (right side). All six profiles (pairs of tubes) are shown for each one of the shafts.

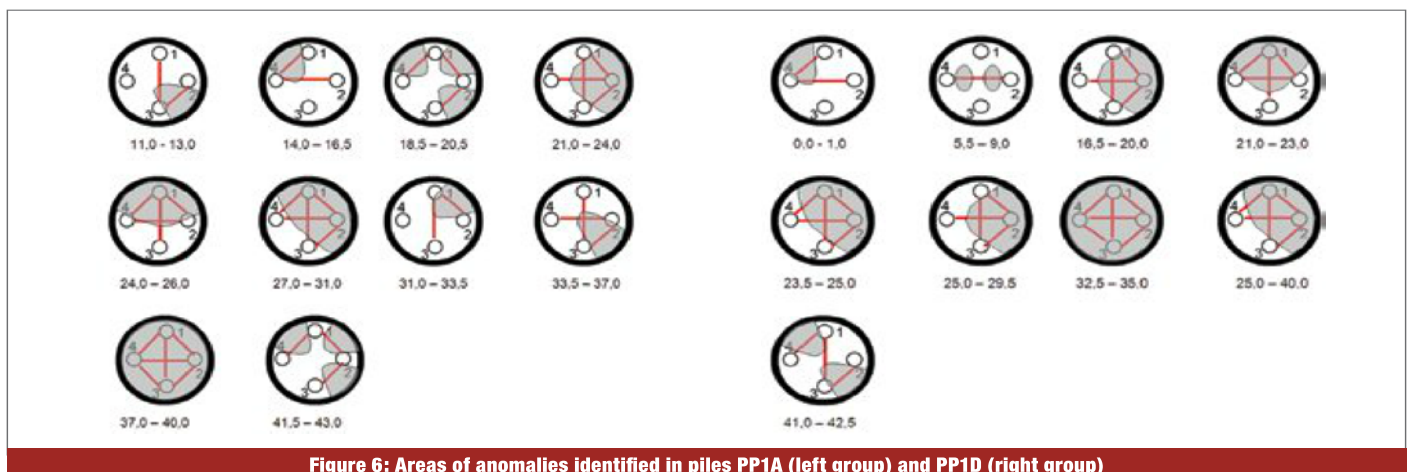
Figure 6: Areas of anomalies identified in piles PP1A (left group) and PP1D (right group)

Figure 6 represents the cross-section of the shafts at various depths, with anomalous areas shown in gray. Flaws or defects were observed in multiple profiles at each of the depths, in some cases in as many as four of the six tube combinations, indicating defect magnitudes from a quarter to half of the cross-sectional area (note PP1A between 21 and 31 m and PP1D between 16,5 and 40 m). At some depths, anomalies were shown in all profiles at a given depth (PP1A between 37 and 40 m and PP1D between 32,5 and 35 m), indicating that the entire cross-section of the pile at that depth is defective.

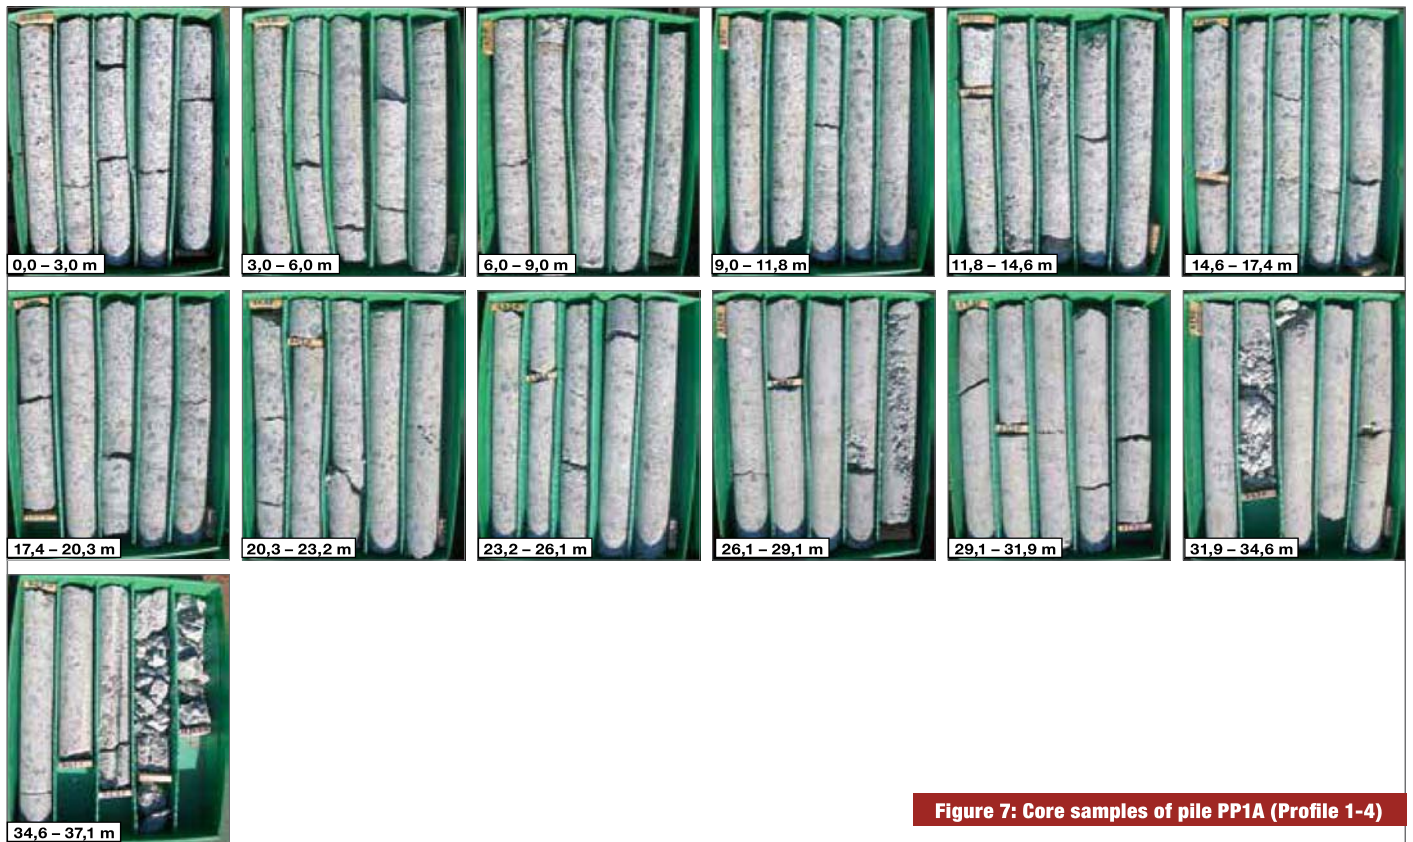
Figure 7: Core samples of pile PP1A (Profile 1-4)

The core samples (Figures 7 and 8) permitted observation of the composition of the pile material and confirmed the anomalies indicated by CSL. The anomalies

were generally caused by an insufficient amount of grout in the concrete. Once the gravity and location of the defects were confirmed, their repair was undertaken

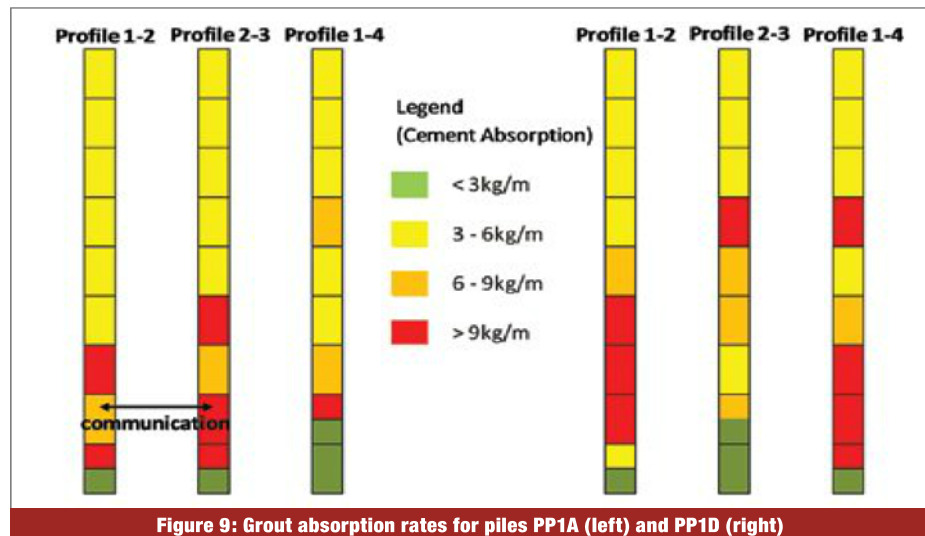
Figure 9: Grout absorption rates for piles PP1A (left) and PP1D (right)

through grout injection. Grout absorption was carefully monitored, as illustrated in Figure 9. The areas of greatest absorption of cement grout appear in red. In general

these areas occur at depths below 15 m, corresponding to the depths identified by CSL and shown in Figures 4, 5 and 6.
