# Large Diameter Cast-in-Place Concrete Piles Whitestone Expressway Project

This project in New York City involves the replacement of the northbound Whitestone Expressway over the Flushing River at the Van Wyck Expressway interchange. Three fixed span structures over the river will replace a bascule bridge that was built in 1939. The three structures over the river include the northbound Van Wyck Expressway ramp, Astoria Boulevard approach along the mainline northbound Whitestone Expressway and a ramp to Linden Place. Reconstruction of the ramp to southbound Van Wyck Expressway is also included in this work. This New York State Department of Transportation (NYSDOT) project was awarded in 2003 at a cost of \$177 M. Located in the Flushing Meadows section of Queens, the project is near LaGuardia Airport, Shea Stadium, the U.S. Tennis Center, and the site of the 1939 and 1964 World's Fairs.

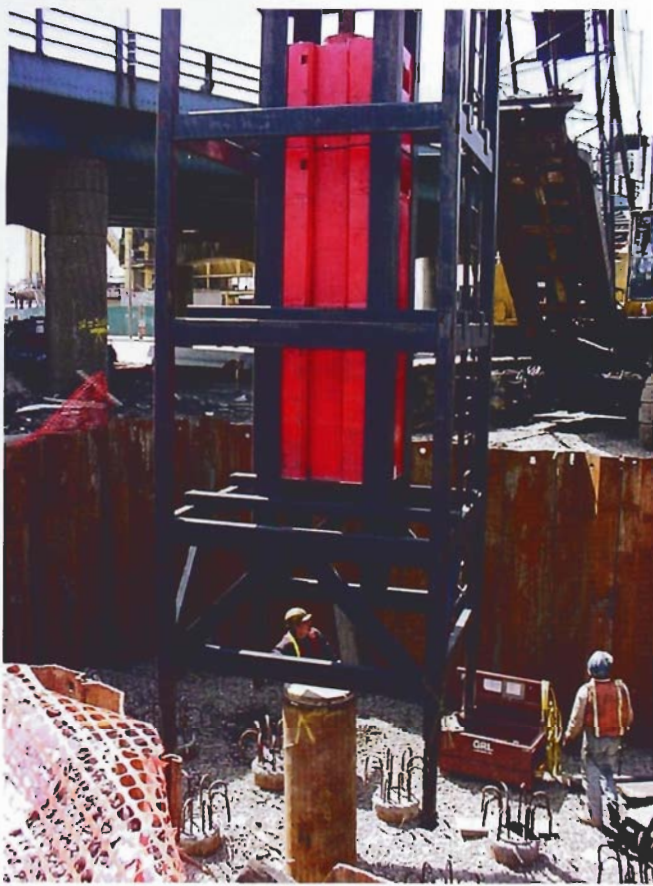
Apple Test

Seven months after the SPLT an Apple test was run using a 40 kip weight dropped at heights of 2.0, 3.5 and 4.6 feet with standard PDA equipment used for the strain and acceleration measurements. A virtually frictionless free fall of the weight is obtained by cutting the steel support cable with a remote hydraulic device. All of the footing piles were driven one month prior to the Apple test. A simulated static load-set plot obtained from the CAPWAP analyses showed the pile achieved a plunging failure at a higher load but at the same movement as the SPLT. The higher measured load from the Apple test was likely due to the longer setup period and consolidation of the soil caused by driving the surrounding footing piles.

monitoring was also conducted on this pile during initial drive and restrike. The steel pipe did not have sufficient section to resist the expected failure load from the SPLT test therefore it was filled with concrete before the test. Consequently the diesel hammer was unable to sufficiently move the pile during the PDA restrike test that was performed after the SPLT. In order to determine the correlation between the SPLT and PDA results a restrike was done using the GRL Engineers' Apple system with a 40 kip drop weight.

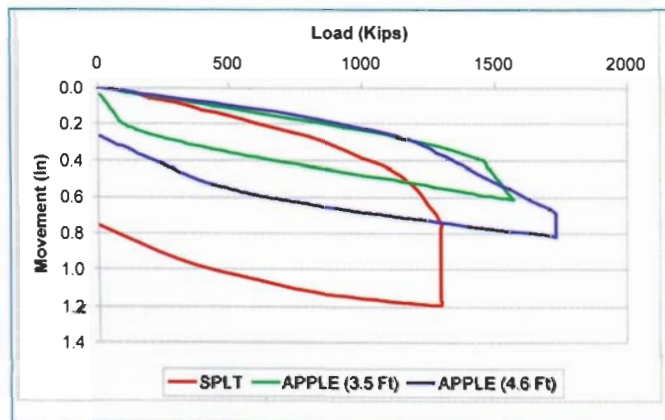
SPLT and Apple Load-Movement Plots

Early in the foundation work, it became a challenge to find a location that was accessible to the pile driving equipment and with sufficient space to construct the SPLT frame. Locations with the deep Organic Silt deposits combined with a thin veneer of Fill were not desirable to set up wood cribbing or drive reaction piles. Therefore the 24 inch diameter SPLT pile was installed at a footing location for 18 inch piles where the Organic Silt layer is thin and the Fill layer substantial. Since the pile was utilized in the foundation, it was located in the center of the footing where it could have the least effect on the lateral stiffness of the pile group. The load reaction was provided by eight tapered Monotube piles and steel billets supported on wood cribbing. The SPLT was conducted one month after the pile was driven. The toe of the 74 foot deep pile was in Silty Clay and it achieved a plunging failure load of 1300 kips at a top movement of 0.75 inches.

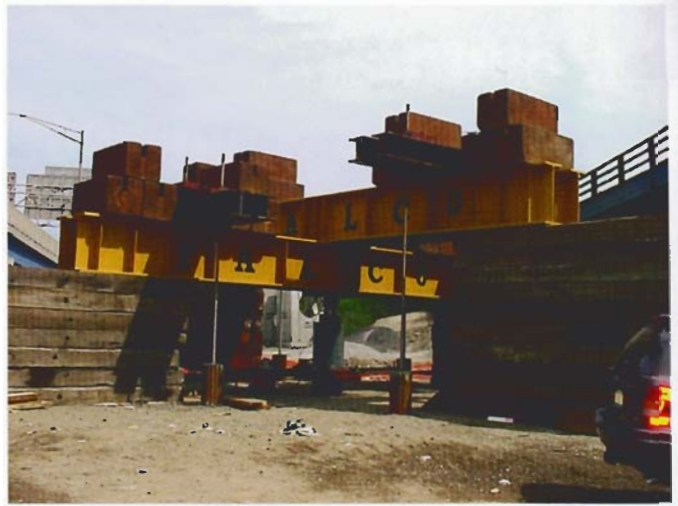
Static Pile Load Test

The piles were driven with a Delmag D46-32 single acting diesel hammer which has a rated energy of 122 kip-ft at the maximum stroke. Pile Driving Analyzer (PDA) monitoring was used to evaluate hammer operation, measure driving stresses and establish pile driving criteria through capacity verification. A static pile load test (SPLT) was conducted on the first 24 inch diameter pile installed on the project. PDA
