Philadelphia Dock Story—Pile Challenges at Delaware River

A new ship dock at a Philadelphia area refinery will be capable of docking the largest tanker to travel the Delaware River, the Stena V-MAX, which will induce significant lateral loads. The loads at the dock, a system of mooring dolphins and platforms, will be resisted by over 150 pipe piles, including some 20- and 30-in diameter, reinforced, concrete-filled pipe piles and H-piles. Construction included driving the pipe piles to the required ultimate capacity, flushing the pipe pile casing clean of overburden materials, followed by drilling rock sockets into the underlying Wissahickon Formation. The Wissahickon Formation is a complex subsurface that includes variations in depth to bedrock, rock quality, degree of weathering and the presence of very hard quartzite lenses or inclusions. Because of the problematic subsurface, the designers and client requested extensive pile dynamic analysis (PDA) testing by **TRC Engineers** (TRC).

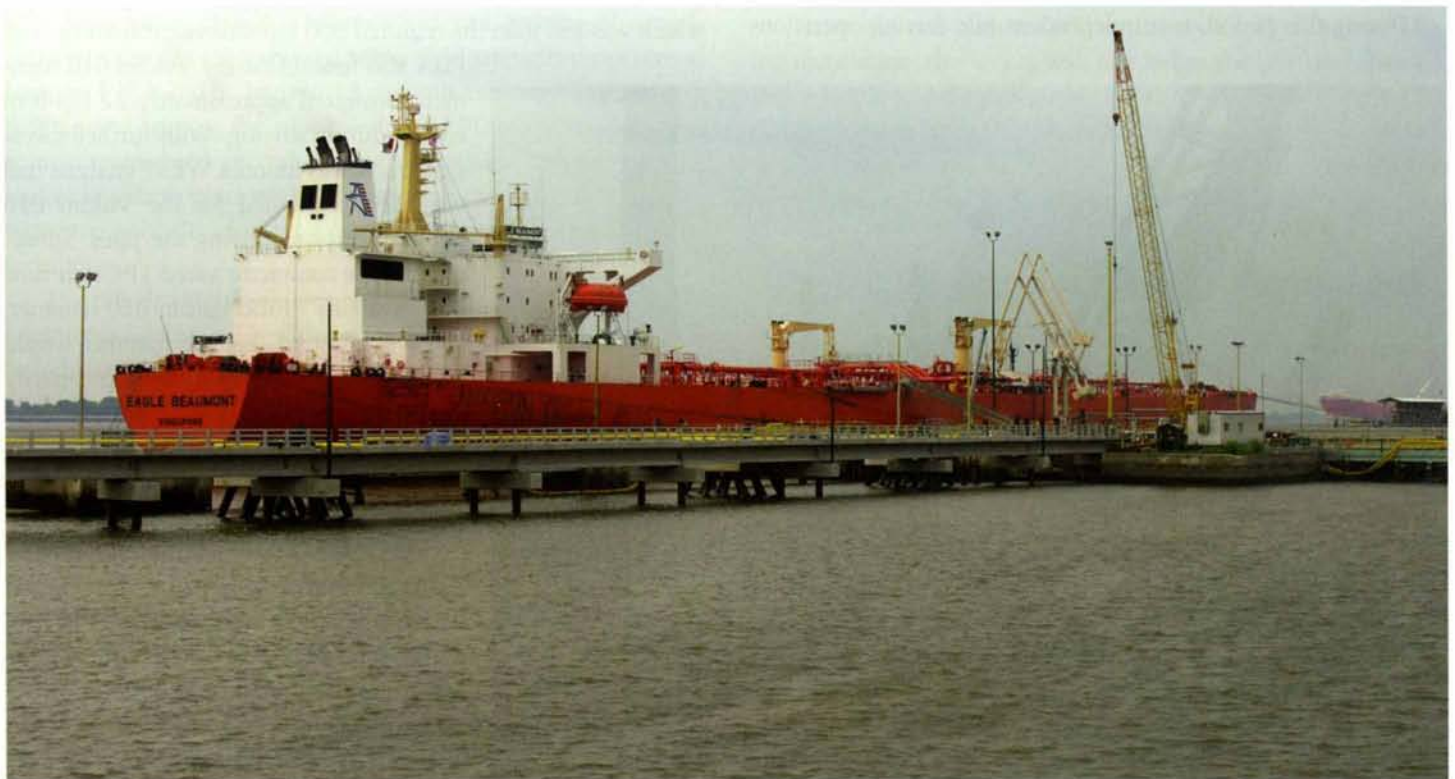
Upriver approachway

The upriver accessway bents and dolphin structures D6, D7, D8 and Alpha were installed between October 2006 and July 2007. New challenges were encountered prior to driving the pipe piles during PDA pile preparations due to the use of pipe piles with very high yield strength. Independent test reports of sample material from the piles showed some yield strength properties as high as 135 ksi! The high yield strength caused problems with drilling and tapping the pipe pile for the PDA sensors. The TRC team implemented special drilling operations for this material, and were able to successfully drill and tap the holes for PDA testing using specialty drill bits, cutting oils and low-speed drilling techniques.

The pile driving operations along the upriver accessway bents commenced in an upriver direction from the main dock. It was found that high blow counts coincided with piles that had high end bearing with little penetration into either the quartzite or decomposed mica schist layers. Typically, when blow counts were above 10 blows per in, the piles had most of their CAPWAP resistance at the pile toe. Conversely, when blow counts were less than 10 blows per in, the CAPWAP resistance had more of the ultimate resistance distributed along the shaft—approximately 50 to 69% of the total capacity. The upriver bents had ultimate capacities ranging from 813 to 1,713 kips, and corresponding blow counts ranged from 5 to 14 blows per in. During pile driving, the PDA system monitored the driving compression stresses, which were kept below 39 ksi. An ICE I-46 hammer was used at the accessway bents and transferred approximately 38% of the rated hammer energy, which is above average.

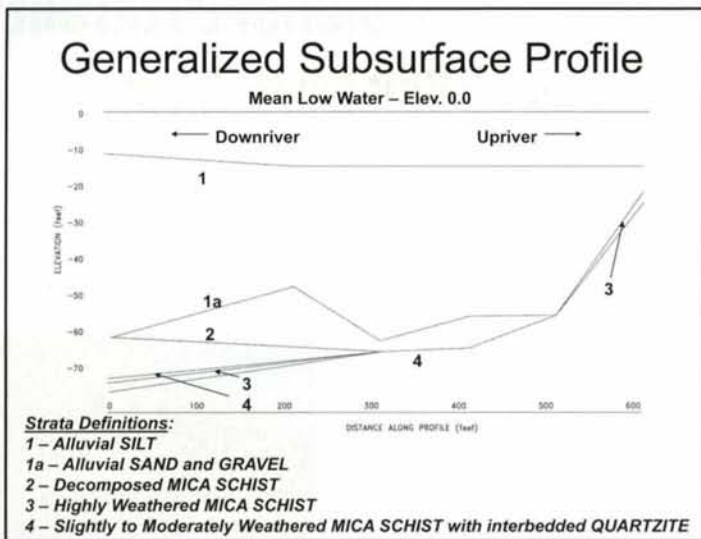
Generalized Subsurface Profile: Ship Dock

The Wissahickon Formation is a complex subsurface that included variations in depth to bedrock, rock quality, degree of weathering and the presence of very hard quartzite lenses or inclusions.

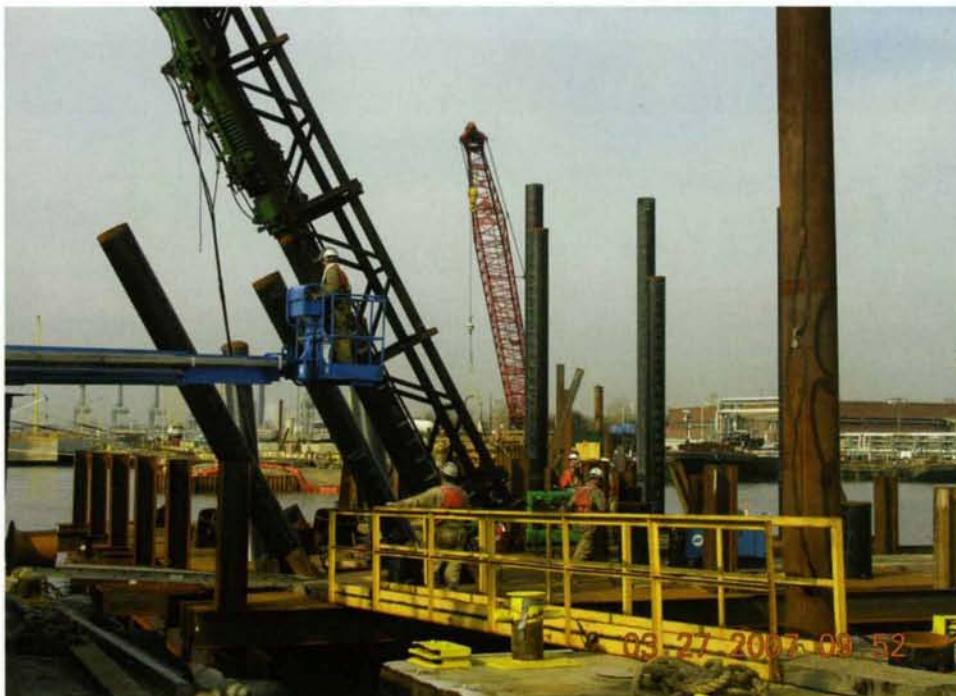
PDA testing at Bravo

Driving the 28 pipe piles at the Bravo structure revealed some of the shortest pile tip elevations due to higher quartzite inclusions and mica schist layers. Initially, the piles were vibrated into position approximately 3 to 8 ft before impact driving. The plumb piles had penetrations of 5 to 10 ft using the ICE I-46 impact hammer, while the battered piles had impact hammer penetrations of only 1 to 3 ft. Pile capacities ranged from 850 to 1,560 kips for the plumb piles and 870 to 1,190 kips for the battered piles. The compression stresses stayed within 36 ksi.

In March 2007, during the initial driving operations for one of the Bravo piles, the PDA recorded signs of impedance changes approximately 3 ft from the pile toe. After discussion, the project team decided to remove the pile, and the damage was verified at the pile toe. The extracted pile was redriven to a final driving resistance of 10 blows per in and was successfully drilled out for a rock socket. It is believed the pile hit an obstruction due to the hard quartzite layers that created local stress concentrations and consequently, the pile damage.

Overall, the pile driving operations at the Bravo structure were slightly more difficult than the other dolphin structures due to (1) the orientation of the batter piles that limited the sequential pile installation; and (2) the mica schist/quartzite layers were problematic due to the rock quality, degree of weathering and the presence of very hard quartzite inclusions. Both issues prolonged construction times. The PDA provided real-time QA data regarding the pile capacity, driving stresses, hammer performance and pile integrity.

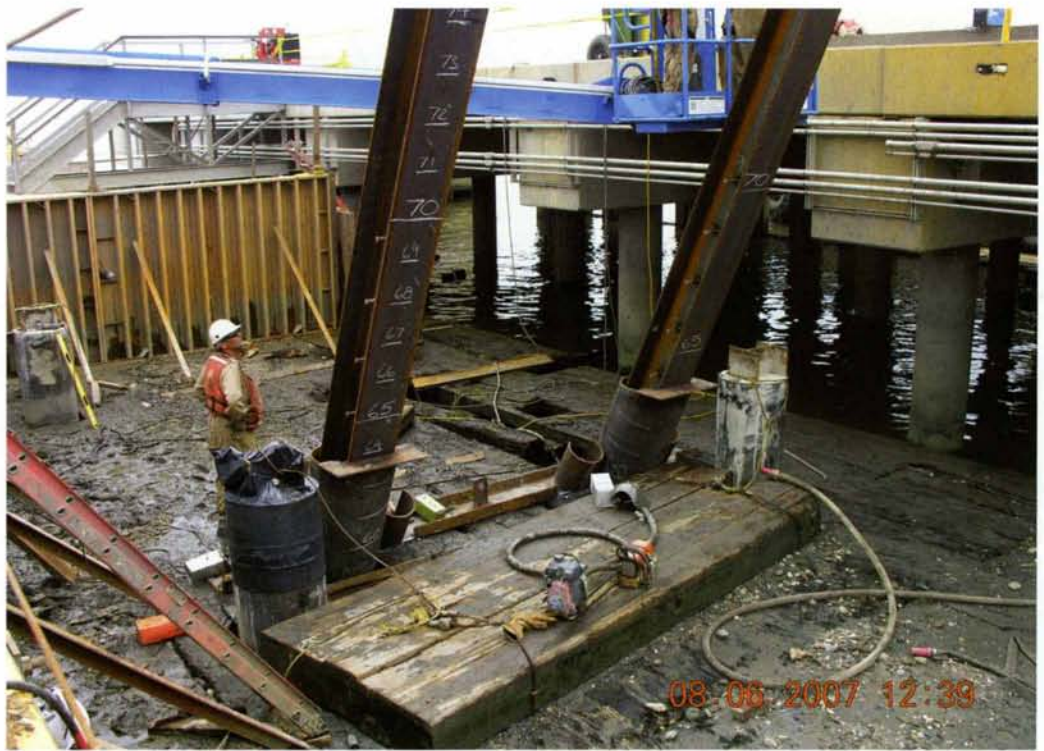
Dock Section B

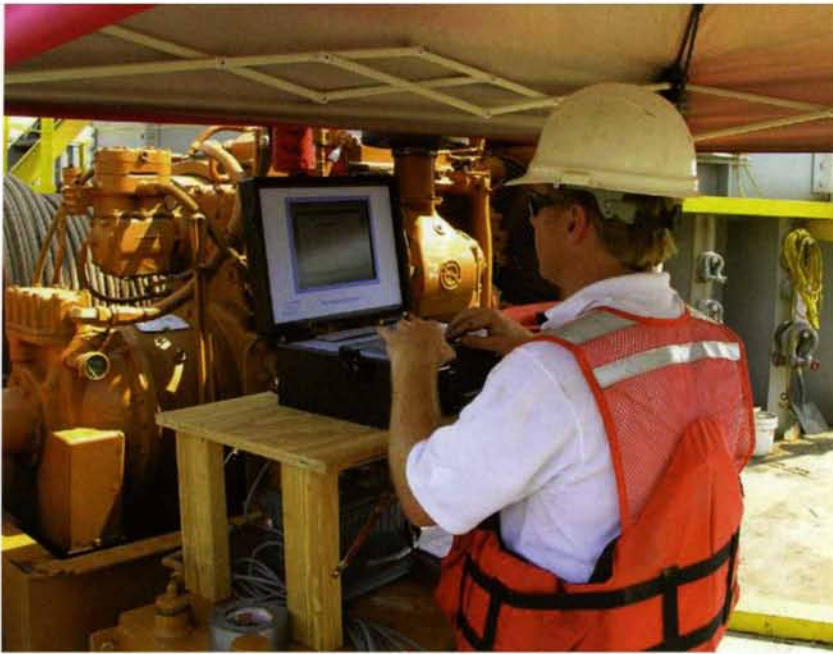
PDA testing
