# Case Histories Utilizing Thermal Integrity Profiling for Foundation Quality Assurance

Marty Bixler, P.Eng., P.E.  
GRL Engineers, Inc., Maple Valley, Washington, U.S.A.  
Daniel Belardo  
GRL Engineers, Inc., Solon, Ohio, U.S.A.  
George Pisciak, P.E.  
Pile Dynamics, Inc., Solon, Ohio, U.S.A.

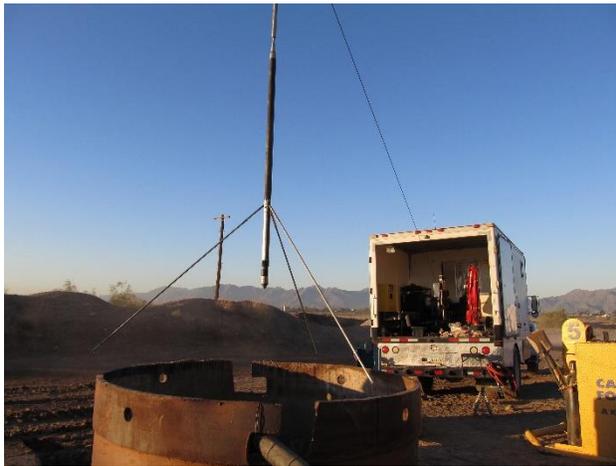
After each shaft was excavated and prior to the setting of the rebar cage and concrete, a borehole caliper tool was lowered down each shaft. The mechanical borehole caliper is an inspection device that measures the diameter and shape of a borehole prior to concrete placement. Once lowered to the base of the excavated shaft, the mechanical arms make contact with the borehole wall and measure the diameter over the shaft length as the unit is raised. The mechanical caliper used for inspecting TS-1 and TS-2 is shown in Figure 3.

Figure 3. Photo of mechanical caliper

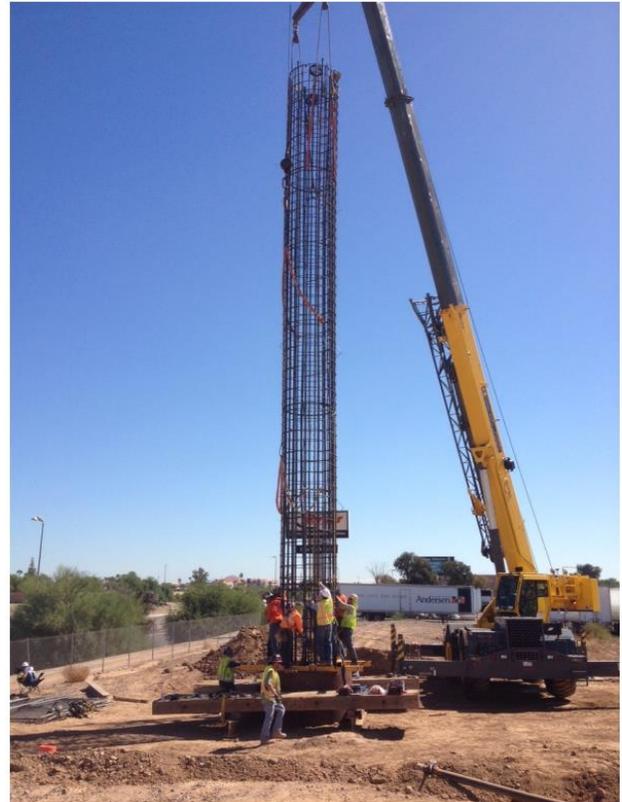
Figure 4. Photo of rebar cage for TS-2

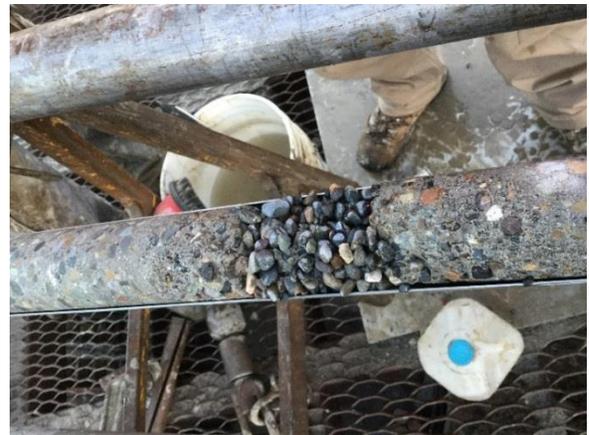
Due to the estimated reduction in radius to inside the reinforcing cage, the shaft was cored to try to locate the extent of the anomaly. Since coring outside the cage is in most cases not feasible, the first core was reportedly drilled 18-inches inside the reinforcing cage between Wires 7 and 8. This location was selected due to Wires 7 and 8 showing the maximum reduction in radius. The core was angled slightly so that near EL.-87 the core would be in close proximity to the cage. The core taken at this depth is shown in Figure 10.

Figure 10. Core from Pier 9 Shaft C near EL.-87

The core revealed a segregated or washed out region of concrete in the shaft near EL. -87. When compared to the TIP model, these results correlate exceptionally well. When viewing the Effective Local Radius vs. Elevation plots, the vertical extent of the contaminated region inside the reinforcing cage appears to be approximately 1-foot near the location of Wires 7 and 8. The core sample taken from this region confirmed these results. It was reported that additional cores were taken to determine the radial extent of the segregated region. Cores taken near the center of the shaft and diametrically opposite of the core taken near Wires 7 and 8 revealed good quality concrete which also correlates well with the TIP model. Once coring was completed, it was reported that the cored holes in the shaft were inspected with a camera and then hydro-blasted, and pressure grouted.
