USING THERMAL INTEGRITY PROFILING TO EVALUATE THE STRUCTURAL INTEGRITY OF SOIL NAILS

George Piscsalko, P.E., Pile Dynamics, Inc., Solon, Ohio gpiscsalko@pile.com, Camilo Alvarez, P.E., GRL Engineers, Inc., Los Angeles, California, Daniel S. Belardo, GRL Engineers, Inc., Solon, Ohio, Marcus Galvan, P.E., TXDOT, Austin, Texas

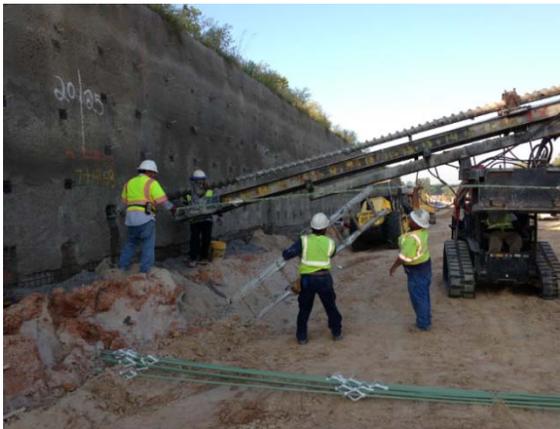
Figure 2: Excavator Mounted Drill Attachment

Soil nail walls offer multiple advantages when compared to other earth retaining methods such as driven soldier pile and lagging walls or sheet pile retention systems with tie back helical anchors and walers. Generally, systems requiring driven piles require sizable heavy equipment, including both a crane and hammer system. In comparison, soil nails require much smaller equipment to install, generally an excavator with a mountable drill attachment (Figure 2). Advantages can be recognized on projects where site access is limited, there are right-of-way restrictions, stabilization is required under an existing structure, and where transporting equipment to remote locations is required. Other advantages include rapid construction, low noise pollution on the surrounding environment, ease of material procurement, and cost savings. Experience on U.S. highway projects indicate that permanent soil nail walls can provide a 10 to 30 percent cost savings when compared with similar retaining methods involving soil excavation (Lazarte et al., 2003).

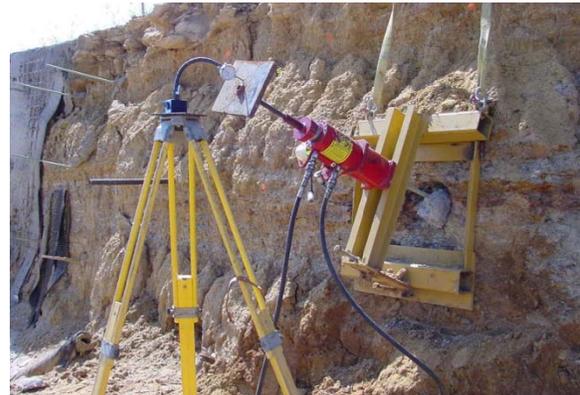
Figure 3: Jack and Reaction Frame

Verification and proof testing are two widely accepted quality control measures used to ensure the nails can withstand the design loads. Typically, the set up includes a reaction frame that bears directly against the existing soil or shotcrete facing (Figure 3). A hydraulic jack and pump is used to apply the required loads to the centered tension rods and the distance of movement is monitored. When verification tests are performed, the nails are loaded to the designed pull out capacity. During proof tests, nails are loaded incrementally and held for a specified duration of time. Generally, when a contractor moves to a new location or when the soils encountered during excavation are different than those present in the location of the load testing, additional load tests are required.

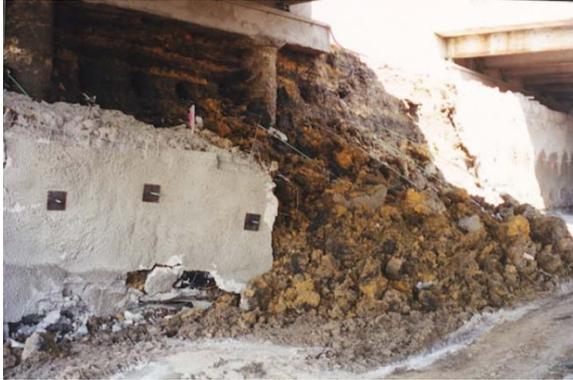
Figure 4: Failed Soil Wall System – It is evident the nails had insufficient grout coverage

The limitation of load testing is that only a small quantity, typical 5 percent, of elements are tested. Load testing is also highly dependent on the assumption that the contractor's installation means and methods, as well as soil conditions, are consistent on elements installed following load testing. Figure 4 presents the failure of a nailing wall after load testing was performed.

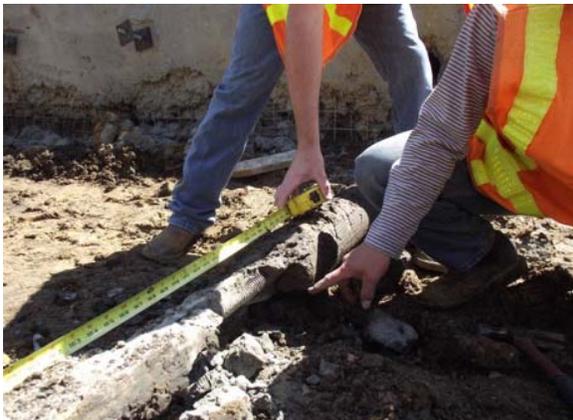
Figure 5: Insufficient Grout Coverage

Evaluating the excavated shaft prior to grouting is difficult to assess because of the relatively small diameter. Ensuring adequate grout coverage around the tension bar for the entire length is another limitation. It is not possible to assess the integrity of soil nail elements with Non-Destructive Testing (NDT) methods such as Cross Hole Sonic Logging (CSL) and Gamma-Gamma Logging because they require access tubes. Pile Integrity Testing (PIT) is typically limited to a length/diameter ratio (L/D) of 30. Due to the small diameter of soil nails in relation to the length, PIT testing is likely not a feasible option. Figure 5 and Figure 6 present soil nails that were extracted after completion. It is evident in the results that there were lengths of the tendon with insufficient grout coverage.

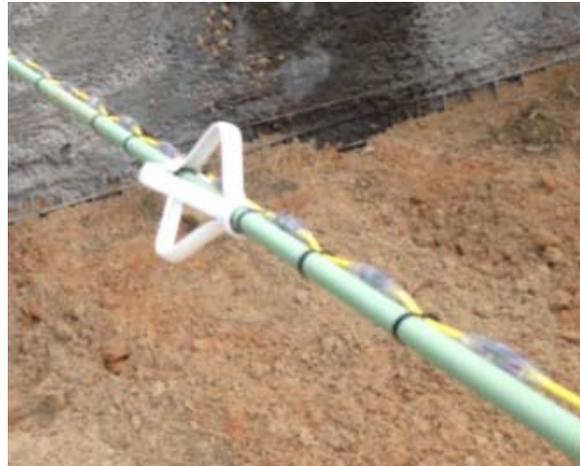
Figure 7: Thermal Wire Affixed to Tension Bar

The soil nails tested were 6 inches in diameter and contained a #6 epoxy coated center bar. Centralizers were located at 3-4 locations along the length of the shaft. The Thermal Wire cables measured 20 ft. in length (40 digital sensors) and were affixed to the center bars of Test Nails 1-4 using zip ties spaced ever 1-2 ft. The cable connection to the center bars was completed while the center bars were staged on the ground prior to placement in the excavated shafts (Figure 7).

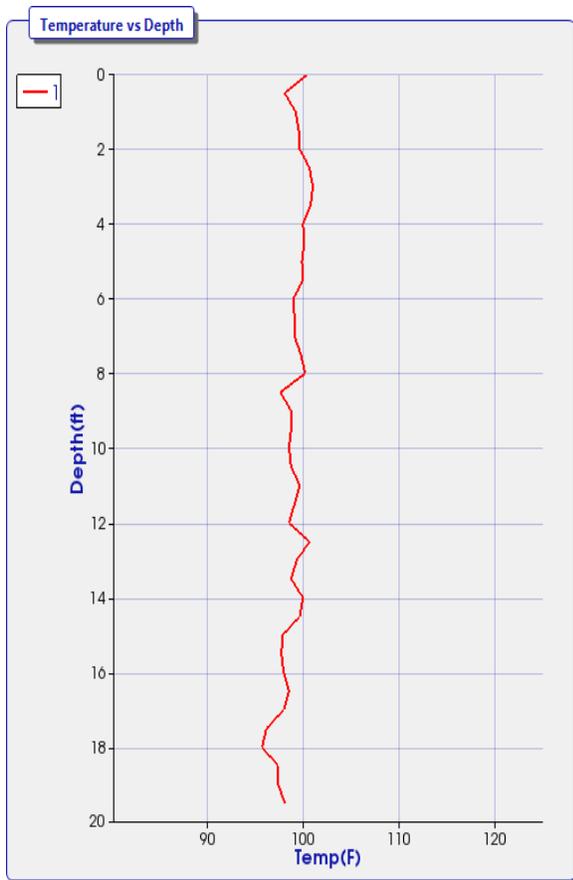
Test Nail 1: Temperature readings throughout the length of the nail are consistent and thus no major indications of structural integrity problems are observed. Minor changes in temperature are noticeable, most likely due to the center bar shifting slightly within the nail. The upper 8 to 9 ft. of the nail recorded higher than average temperature values which is likely an indication of an increase in cross sectional area at these locations. At the centralizer locations of 9.9 ft. and 19.3 ft. measured temperatures are very similar to the average temperature, as the center bar gets closer to the center of the soil nail.

Figure 9: TN-1 Measured Temp. vs. Depth

The Thermal results are presented in Figure 9 through 12. These figures present the measured temperatures (Fahrenheit degrees) vs. depth (feet) at different curing times. The roll-off (e.g. reduction) in temperature at the top is caused by extra heat losses due to the grout/air interface at the ground surface. There is generally a roll-off in temperature near the end of a grouted element caused by extra heat loss due to the grout/soil interface at the base but for TN-1, TN-2, and TN-4 the Thermal Wire stopped short of the end of the shaft.

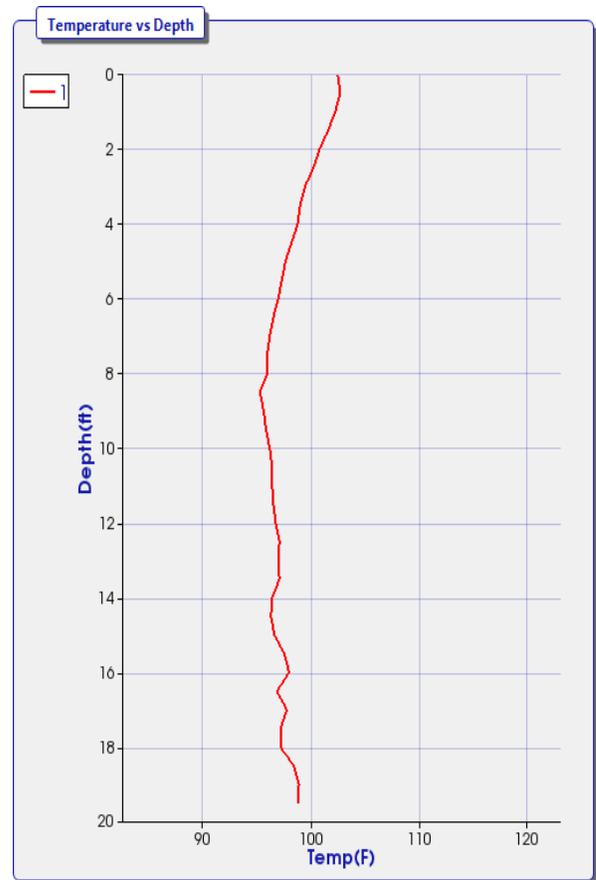
Test Nail 2: Temperature readings throughout the length of the nail are consistent and thus no major indications of structural integrity problems are observed. Minor changes in temperature are noticeable, most likely due to the center bar shifting slightly within the nail. The upper 5 to 6 ft. of the nail recorded higher than average temperature values which is likely an indication of an increase in area at these locations. Temperature is relatively constant between 11 and 20 ft. due to the presence of the centralizer locations at 10.6 ft., 17.2 ft., and 18.8 ft.

Figure 10: TN-2 Measured Temp. vs. Depth
