Transmission Pier Foundation QC/QA

Gina Beim, P.E., M.ASCE¹; Robert Kluge, P.E.²; Matthew Lohry, P.E.³; and Daniel Belardo⁴

Abstract

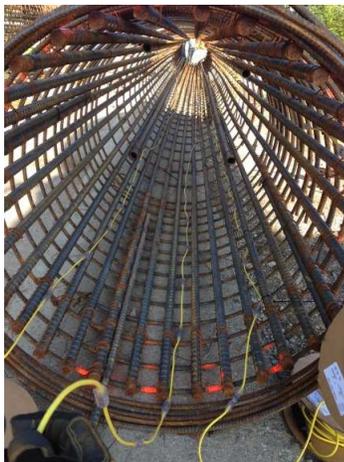
Figure 3. Cables with thermal sensors (detail right) attached to reinforcing cage

When data are obtained from cables (Figure 3), no access tubes are required. This is often advantageous for transmission line foundations where the geometry is such that installation of access tubes is challenging. Each of several cables within a shaft has thermal sensors at every 0.30 m (1 ft), and is outfitted with a battery-powered data acquisition unit that records temperatures at 15-minute intervals. The entire concrete curing process is monitored, and data are collected on site at any time after casting.
