**Conference:** IFCEE2018 - International Foundations Congress and Equipment Exposition

**Paper Title:** Bonner Bridge Replacement Project - Pile Driving Experience

**Authors:** Scott Webster<sup>1</sup>, Karen Webster<sup>2</sup>

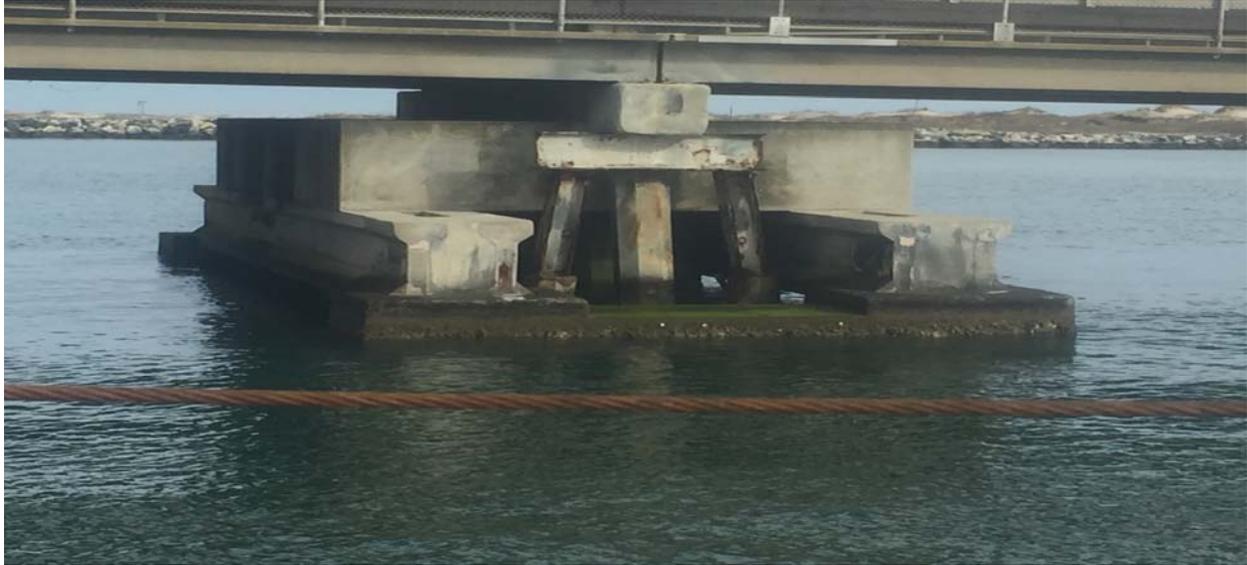
Figure 1. Typical underpinning of original bridge bent.

The original bridge design likely had little or no analysis of the area scour conditions and the effect such conditions would have on the bridge foundations. As such the current existing bridge has experienced numerous scour events which have reportedly undermined the existing bridge pile foundations. Such undermining has resulted in numerous bents requiring underpinning. Some bents have been underpinned multiple times, as shown in Figure 1. As such, the proposed bridge replacement was required to be designed for extreme scour conditions. The anticipated scour critical elevations along the bridge alignment range from approximately elevation -22 to -85. Such deep anticipated scour elevations resulted in pile foundations to be extended much deeper than would be required for axial pile compression loading and in additional analyses for pile capacity assessment based upon dynamic pile testing and CAPWAP analysis. The additional analysis will be discussed in detail.

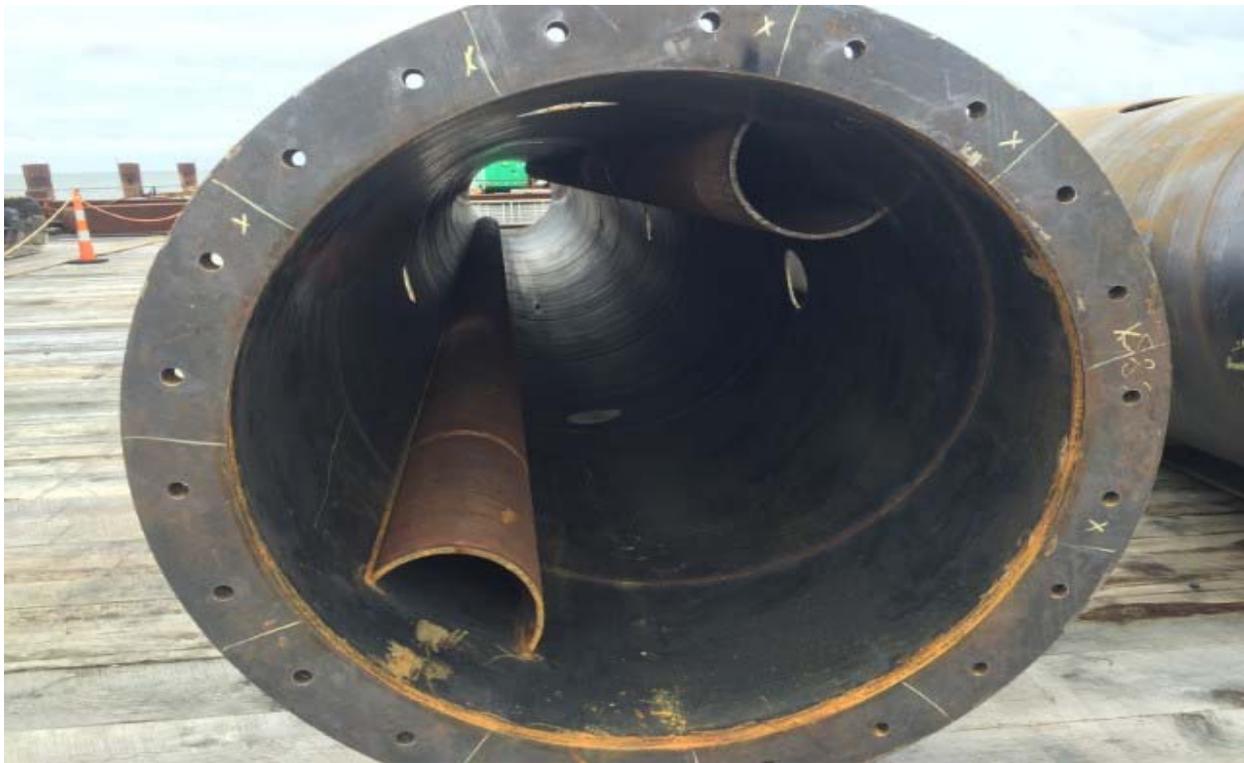
Figure 8. Steel pipe jetting and pile driving guide.

A major concern for the project was the installation of the 36-inch square piles in the navigation zone, through the upper dense sand deposits and to the required minimum tip elevations. While jetting of the piles was the quickest and easiest method, it was unclear to the project team how the jetting process would work for these piles, as all piles were required to be driven on a 2:12 batter. Research of other projects where jetting of large diameter concrete piles on a batter indicated that this type of installation, while common for vertical piles, was typically not done for piles driven on batters. As such, the project team developed an installation plan that consisted of the installation of a template that would accommodate steel pipe sections. The steel pipe sections would be vibrated to a penetration of about 50 or 60 feet and would provide a pile guide for jetting and driving the piles. A schematic of the planned installation setup is shown in Figure 7 and a picture of the steel pipe jetting and driving guide is shown in Figure 8.

Jetting was provided through steel pipe and was controlled by tubular channels welded to the steel pipe sides. This allowed for more accurate guiding of the jetting system. The jetting was performed by two 3-stage jet pumps connected in manifold, with each pump capable of providing 1000 gallons per minute. In addition, compressed air was used to assist the jetting system. A single 1600 cfm air compressor was used in combination with the jet pumps. This system worked very well for pile installation to approximately 10 to 20 feet above the estimated pile tip elevations. In fact, the system has worked with only minor issues and adjustments, and jetting of the piles to any tip elevation desired was easily accomplished. The most difficult adjustment has been to try to predict the ideal elevations to jet the piles to in order to minimize the driving time while not having any detrimental effects on the soil bearing resistance.
