# Empirical Assessment of Base Material for a Drilled Pipe Pile

FEATURE ARTICLE

## Project Description

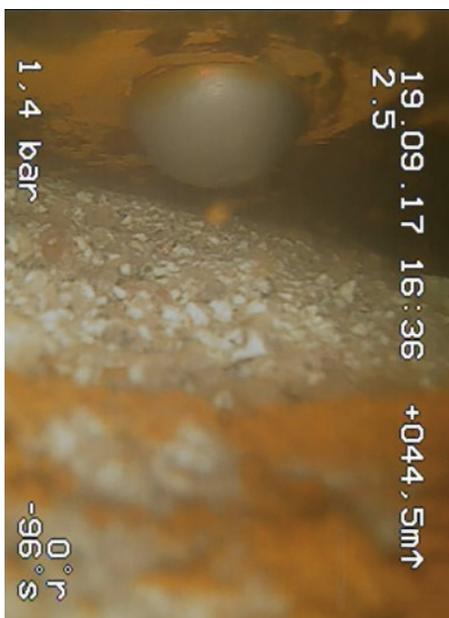
### View of gap between button-bit at bottom of the pipe pile and top of rock layer

The foundation system for the project was designed for end-bearing resistance only, where all of the nominal loads were supported by the base material below the foundations. The following criterion were followed to determine the final base elevation: (1) minimum drilling advance rate of 40 min/m (12.2 min/ft) corresponding to a limit base resistance of approximately 150 MPa (22 ksi) and (2) visual inspection using a down-hole camera to ensure contact between the rock layer and the base of the foundation element. Once the elevation was defined using the drilling rate data, the base of the drilled pile was cleaned using an airlift system, and then a down-hole camera was lowered to inspect the bottom of the pipe to ensure full contact with the rock layer.

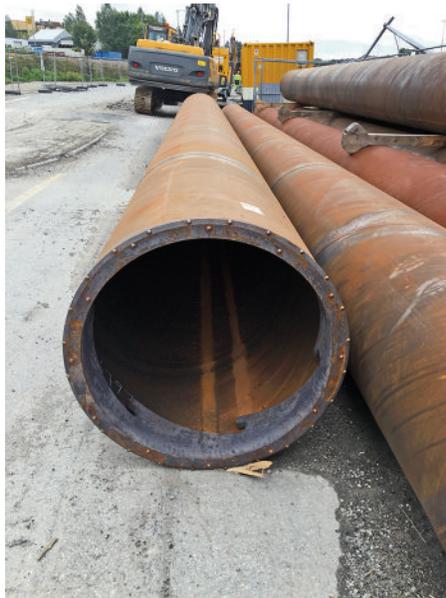
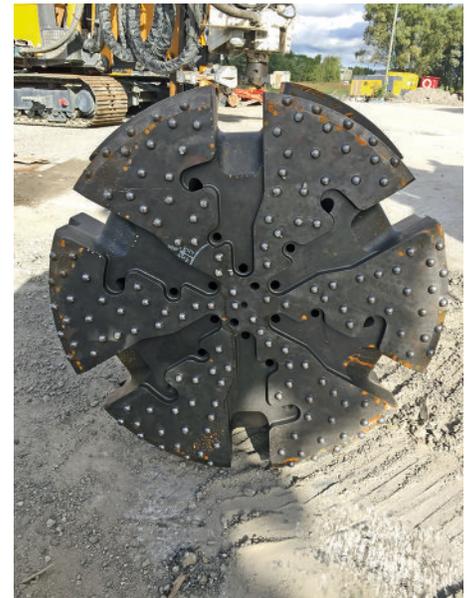
(L) Button driving ring at tip of pipe pile and (R) bottom of a DTH to fit inside pipe pile

The project is related to the foundation system of a vehicular bridge crossing the Seutelva River, located in Fredrikstad, Norway. According to the project information, the proposed bridge will be supported by 25 ea, 1,016 mm (40 in) diameter open-ended pipe piles advanced to the competent rock layer. Each bridge bent consists of five open-ended pipe piles, which will be filled with concrete after reaching the final base elevation. These piles were installed using a DTH hammer system, which uses the rotary-percussion drilling method with a button bit with its outer diameter being the same as the inner diameter of the pipe pile. The

drilling process is completed by using a first pile section with the button driving ring and a button-bit hammer fitted through the pile using a drill string.

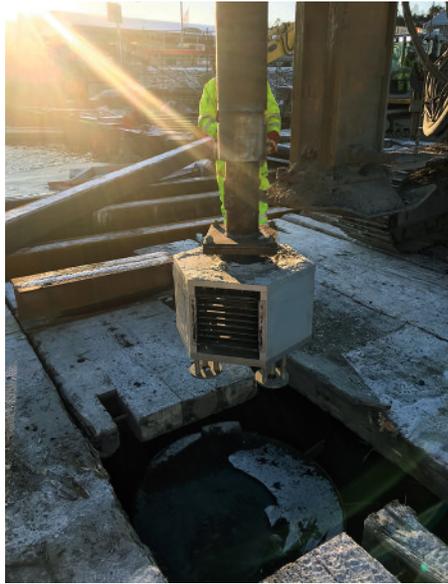
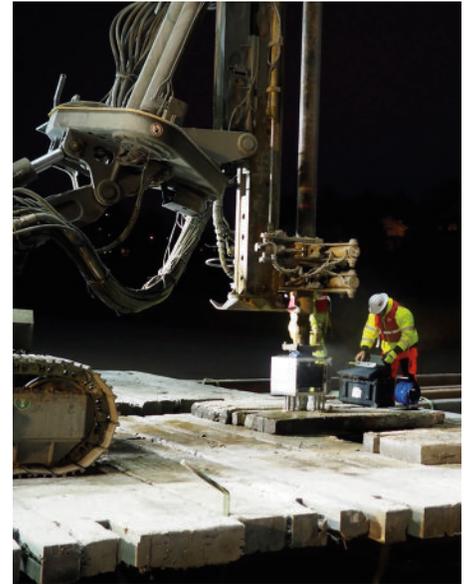
**Attachment of the device to the end of a drill string**

The device was attached to the drill string using an American Petroleum Institute (API) adapter located between the swivel plate and the drill string and was then lowered into the drill pipe to initiate test runs at the base of the foundation. Once the device contacts the base material, an axial force is applied using the crowd (downward thrust) from the drill rig. The resistance to penetration is measured by the penetrometers, while the displacements are measured by the retractable plates.

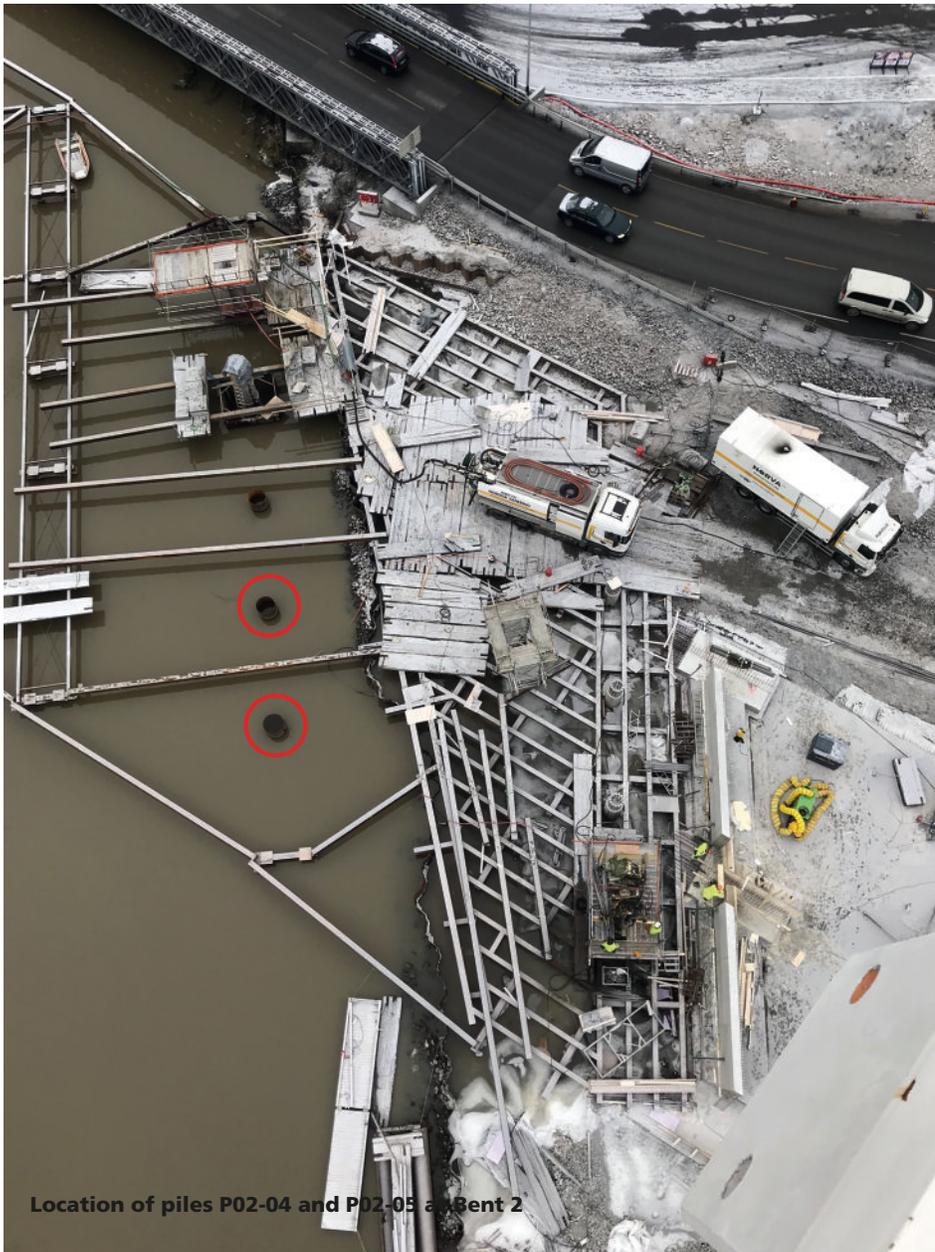
**Location of piles P02-04 and P02-05 at Bent 2**

For two of the piles located on Bent 2 (piles P02-04 and P02-05), the conditions at the bottom of the pile did not facilitate capturing a clear photo or video to confirm the contact between the base of the foundations and the rock surface. In those locations, a third criterion was established based on rock strength properties, where a material with a resistance to penetration of 30 MPa (4.35 ksi) with a deformation less than 8 mm (0.32 in) was classified as a competent rock to receive the foundation and to support the loads.

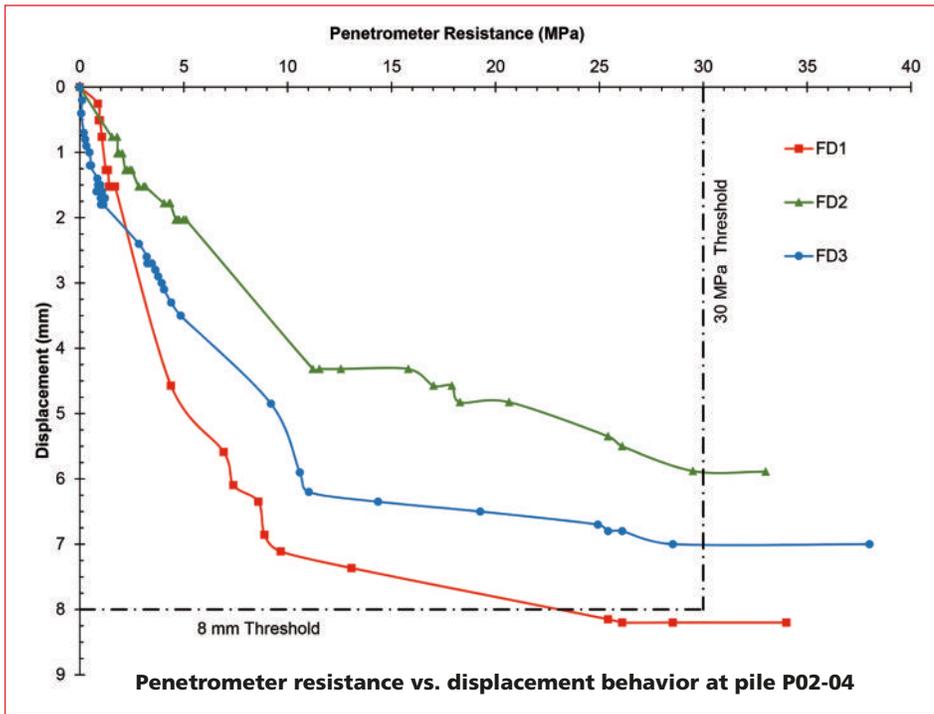
**Penetrometer resistance vs. displacement behavior at pile P02-04**

A total of 10 runs were performed at the base of the pile P02-04 to obtain the data to determine the force-displacement relationship. Each of the applied forces was then divided by the cross-sectional area of the penetrometer to obtain the applied stresses. Stress-displacements plots for pile P02-04 were plotted individually to visualize the force-displacement behavior and to evaluate the criterion established for the material at the base of the foundation. The results obtained for pile P02-04 indicated that each of the three penetrometers follow a similar trend. However, the nonuniform (i.e., not overlapping) plots behavior indicated that the base of the

foundation was not completely flat. Furthermore, according to the plotted results, the average stress and displacement for the material at the base of the foundation were determined to be 35 MPa (5.1 ksi) and 7 mm (0.28 in), respectively. These values were within the established resistance and displacement thresholds for the competent material at the base of the foundation.

It is important to note that FD1 plot slightly exceeds the displacement threshold limit of 8 mm (0.32 in) with a stress value of about 24 MPa (3.5 ksi) and a maximum stress of 34 MPa (5 ksi). However, the other two plots (FD2 and FD3) are within the established threshold values. Another important observation is

the similarity in the shape of the relationships from the start of the test up to approximately 10 MPa (1.45 ksi) where a steady increasing slope is observed. Beyond this point, the relationships transition to a more constant and gentler slope with increasing stress, which may indicate an abrupt change in material property possibly indicating going from softer rock to more competent rock. However, a visual inspection using a down-hole camera, as discussed above, did not reveal softer material accumulated near the base of the foundation. Therefore, the existence of a softer rock versus a more competent rock is more likely to be the case at this location.

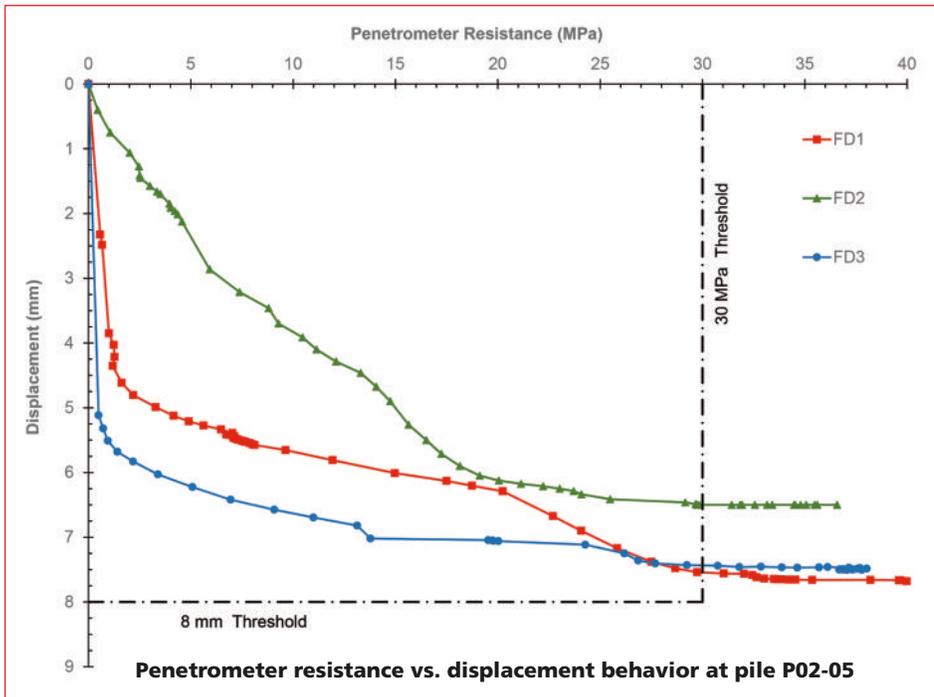
**Penetrometer resistance vs. displacement behavior at pile P02-05**

Similar to those performed at pile P02-04, a total of 13 runs were performed at the base of pile P02-05 to obtain the data to determine the force-displacement relationships. The graphs of the stress-displacement relationships were analyzed to evaluate the behavior of the material encountered at the base of the foundation. The results indicated that each of the three penetrometers follow a similar trend, especially toward the end of the test. Similar to the tests at pile P02-04, a nonuniform material at the base of the foundation was detected, which was evident from the plots as the individual graphs were not overlapping. Considering the maximum stress measured by each

penetrometer and the corresponding displacements, the average stress and displacement for the material encountered at the base of the foundation were determined to be about 38 MPa (5.5 ksi) and 7.2 mm (0.28 in), respectively.

It is important to note that trend of FD2 is different compared to FD1 and FD3. The relationship for FD2 indicates a linear behavior with a constant slope up to a stress value of approximately 20 MPa (2.9 ksi) when the abrupt change of slope occurs. From this point forward, the relationship

flattens to an almost zero slope with increasing stress along with a very small change in displacement. The relationships for FD1 and FD3, on the other hand, follow a similar shape to each other and can be divided into three segments: (1) a steep slope from a stress of 0 to about 1.7 MPa (0.25 ksi), then (2) a small slope between 1.7 MPa (0.25 ksi) and 29 MPa (4.2 ksi), and then (3) a near zero slope after 29 MPa (4.2 ksi). The first portion of these plots could correspond to a very soft material accumulated at the base of the foundation,

which is then followed by a material with higher strength (e.g., weak or weathered rock). The third segment is where the abrupt change occurs similar to FD2 and the graphical relationship (similar to pile P02-04) indicates the existence of competent material or rock that satisfies the established criteria.
