Use and Comparison of New QA/QC Technologies in a Test Shaft

Patrick J. Hannigan, P.E.¹ and Rozbeh B. Moghaddam, Ph.D., P.E.²

ABSTRACT

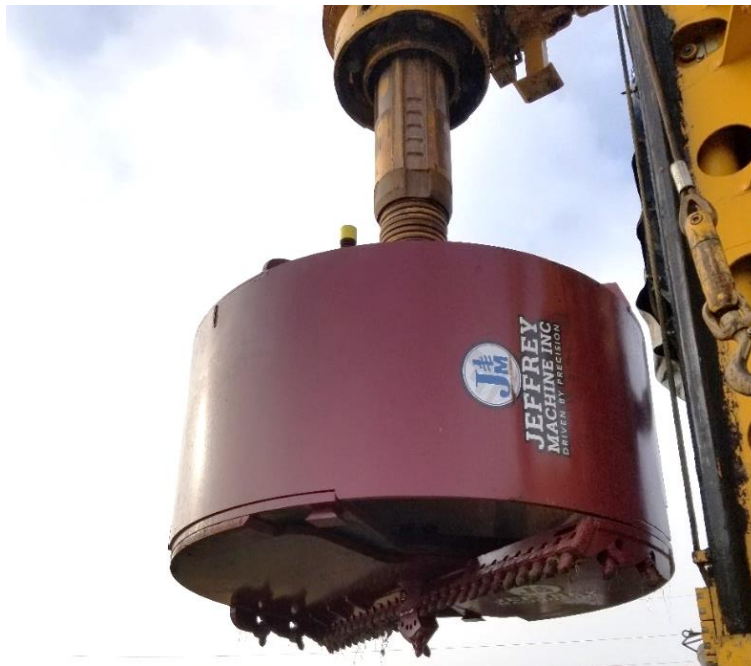
Figure 1. Double Open Drilling Bucket.

The test shaft was constructed by first vibrating a 22.3 m (73 ft) steel casing to a depth of 18.6 m (60.9 ft) below grade. The casing was 2,490 mm O.D. x 16 mm wall (98 in x 5/8 in). A 2,390 mm O.D. (94 in) Double Open Dirt Drilling Bucket, shown in Figure 1, was used to complete the shaft excavation to its' final depth of 32.6 m (106.9 ft). Polymer slurry was used to maintain an open excavation through the uncased zone. Bottom cleaning was performed with this drilling bucket after the auger teeth plate was removed forming a flat bottom cleanout bucket. After cleanout, a full-length, 2,083 mm O.D (82 in) reinforcing cage was installed in the shaft. Concrete, with a design slump of 203 mm (8 in) was then pumped and placed in the shaft via a 254 mm I.D. (10 in) tremie pipe. The final shaft base was at Elevation -32.01 m (-105.0 ft) and the final top of shaft concrete was at Elevation +1.19 m (+3.9 ft).

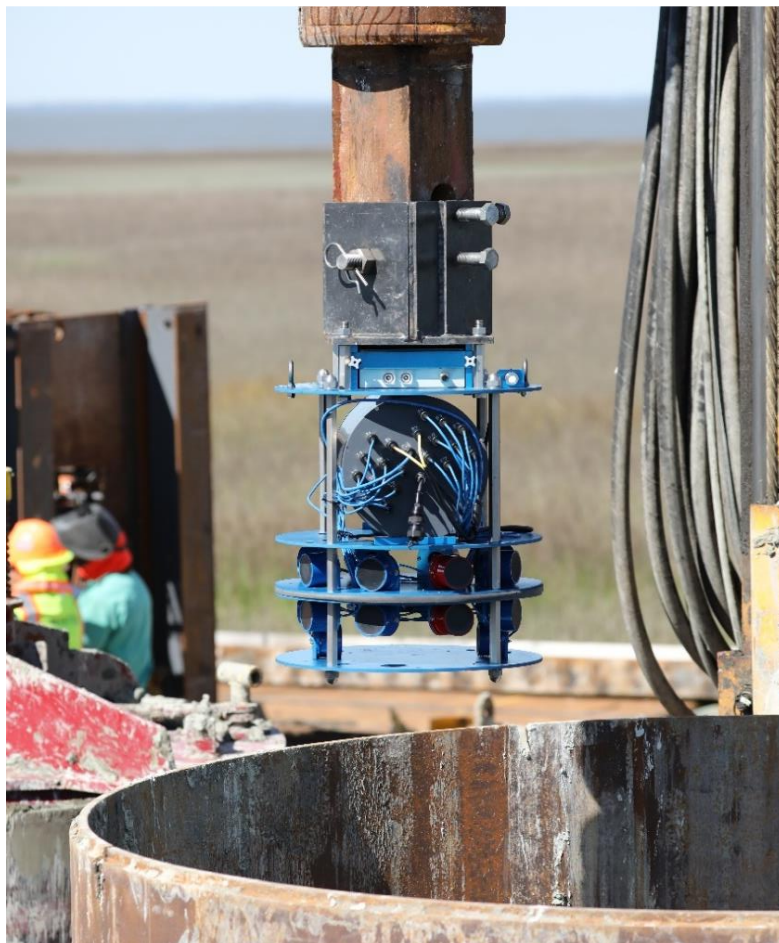
Figure 2. Shaft Area Profile Evaluator.

A SHaft Area Profile Evaluator or SHAPE device was used to determine the characteristics of the wet pour, drilled shaft excavation. The device was pin connected to the drill rig Kelly bar and then lowered into and retrieved from the shaft excavation. While in the wet excavation, this device used eight ultra-sonic pulsers to scan the side walls at a rate of approximately one scan per second. It provided a quick check of the excavation verticality, radii, shape, and drilled hole volume. The test was performed a few hours before inserting the reinforcing cage in the hole. A photograph of the device prior to insertion into the test shaft is provided in Figure 2. Test results, presented in Figures 9 and 10, are discussed later in this document.

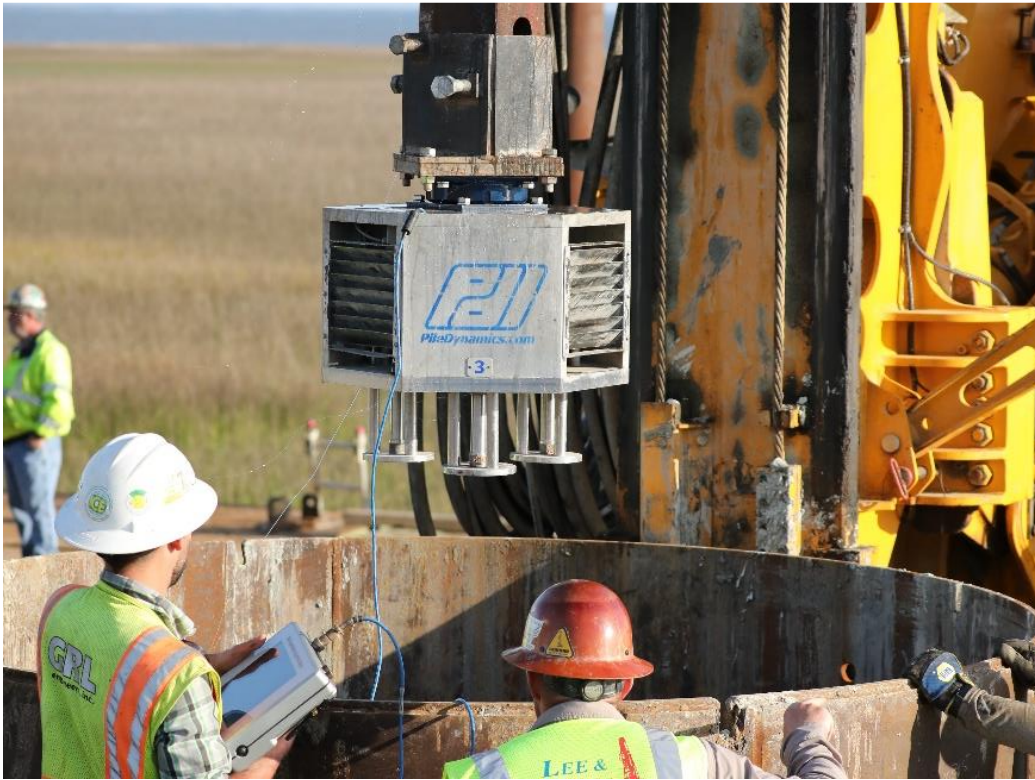
Figure 3. Shaft Quantitative Inspection Device.

A Shaft QUantitative Inspection Device or SQUID was used to check the base cleanliness two hours prior to placing the reinforcing cage and initiating the concrete pour. This device used three 10 cm² (1.55 in²) cone penetrometers and three 521 mm (6 in) displacement plates to assess base cleanliness. For the purpose of sediment thickness measurements, flat tips were attached to the penetrometers for the testing. A photograph of the device prior to lowering it into the test shaft is provided in Figure 3. Base cleanliness tests were performed in the center of the shaft as well as in North, East, and West quadrants of the shaft. The South quadrant test was not performed due to limitations on the drill rig reach. The SQUID was pushed into the base material by the weight of the drill rig Kelly bar. The device penetrometers can be pushed to a maximum penetrometer pressure of 100 MPa (14 ksi). Test results are presented in Figures 11 and 12, with test result discussion provided later in this paper.

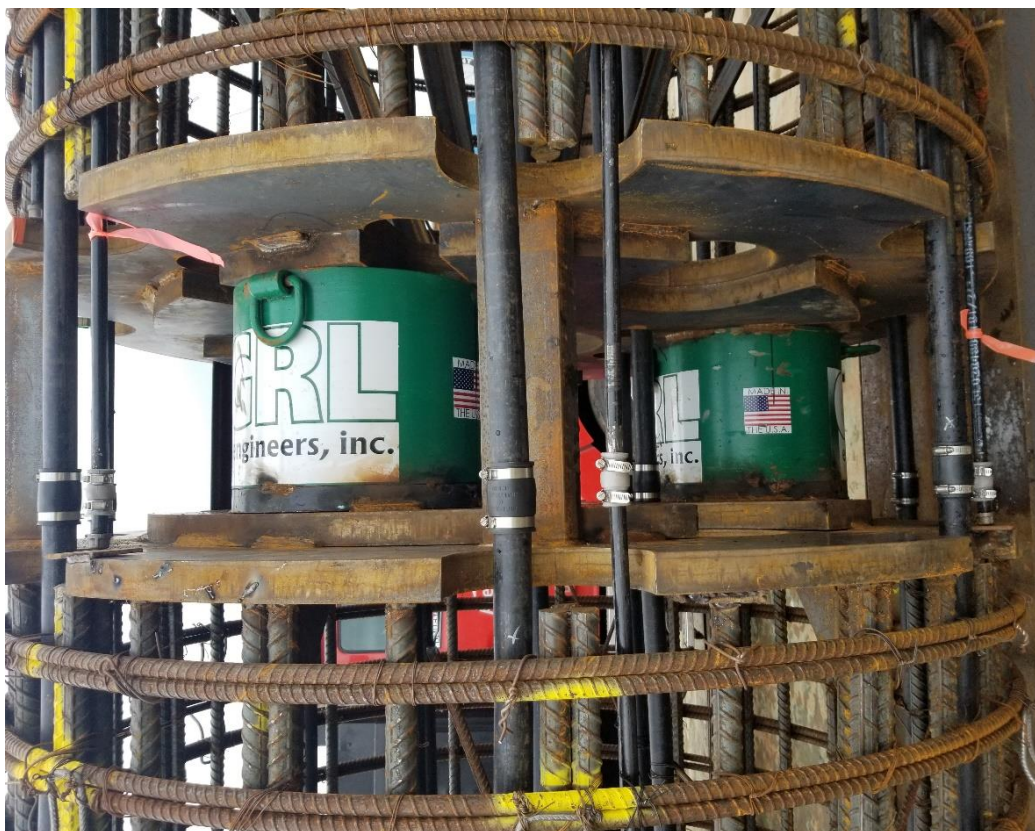
Figure 4. 20 MN Bi-Directional Jack Assembly Attached to the Reinforcing Cage.

Three 6.7 MN (750 ton) capacity GRL-Cells were used in the bi-directional jack assembly. This multi-cell jack assembly was located 4.2 meters (13.8 ft) above the shaft base elevation. The jack-assembly was capable of producing a 20 MN (2,250 ton) jack load and a maximum bi-directional test load of 40 MN (4,500 tons). A photograph of the bi-directional jack assembly prior to insertion in the test shaft is provided in Figure 4. Bi-directional test results are presented in Figures 13, 14, and 15 with discussion presented later in this paper.

The steel cross-hole sonic logging access tubes are shown attached to the interior of the reinforcing cage in Figure 6. The expandable couplers used on the CSL tubes at the location of the bi-directional cells are visible in the bi-directional jack assembly photograph in Figure 4. CSL test results are presented in Figures 16 and 17, with discussion of the test results provided in a subsequent section of this paper.

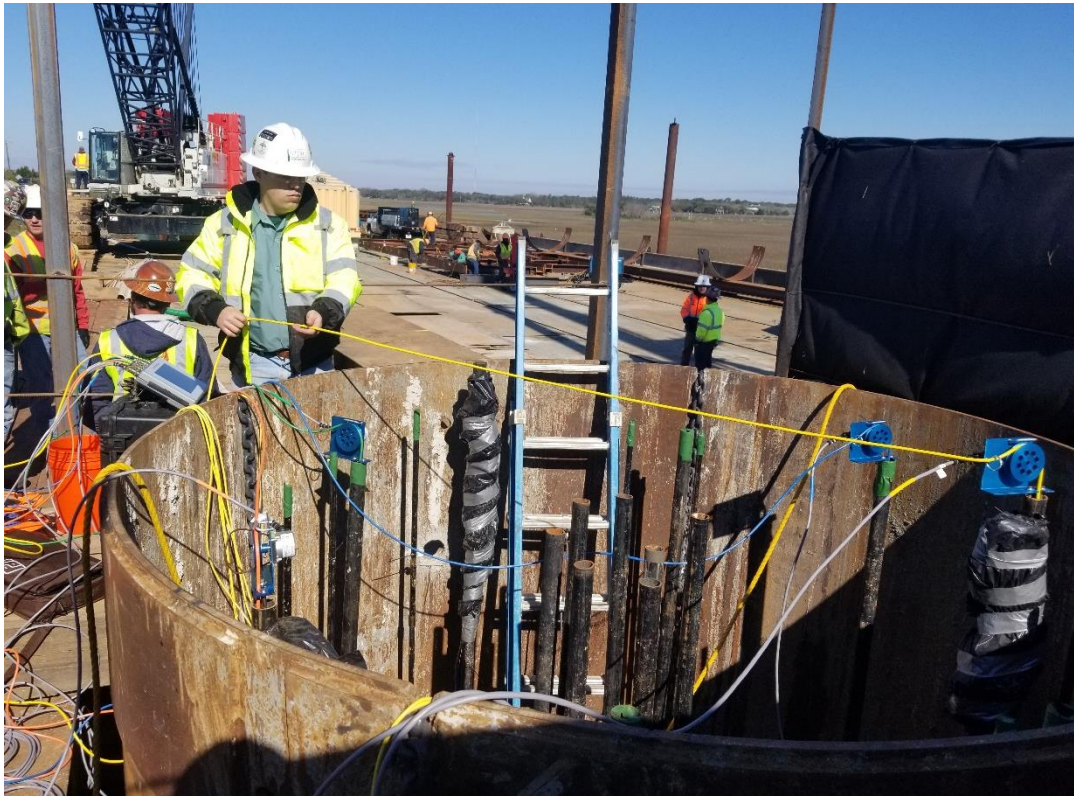
Figure 5. Cross-hole Sonic Logging Test Using Multiple Transceivers.

Access tubes for cross-hole sonic logging were attached to the reinforcing cage at 300 mm (12 in) spacings around the interior of the reinforcing cage. The 38 mm (1.5 in) O.D. steel access tubes ran the full length of the cage, and were pre-cut at the location of the bi-directional jack assembly. The cut access tubes were fitted with expandable couplers at the jack assembly location to accommodate jack expansion. Figure 5 contains a photograph of cross-hole sonic logging being performed on the test shaft. Four profiles were collected and processed concurrently with the CHAMP-Q cross-hole sonic logging system. The multiple transceivers were pulled upwards from the bottom of the CSL access tubes with ultrasonic signals acquired at 50 mm (2 in) vertical intervals as the four transceivers were concurrently raised.

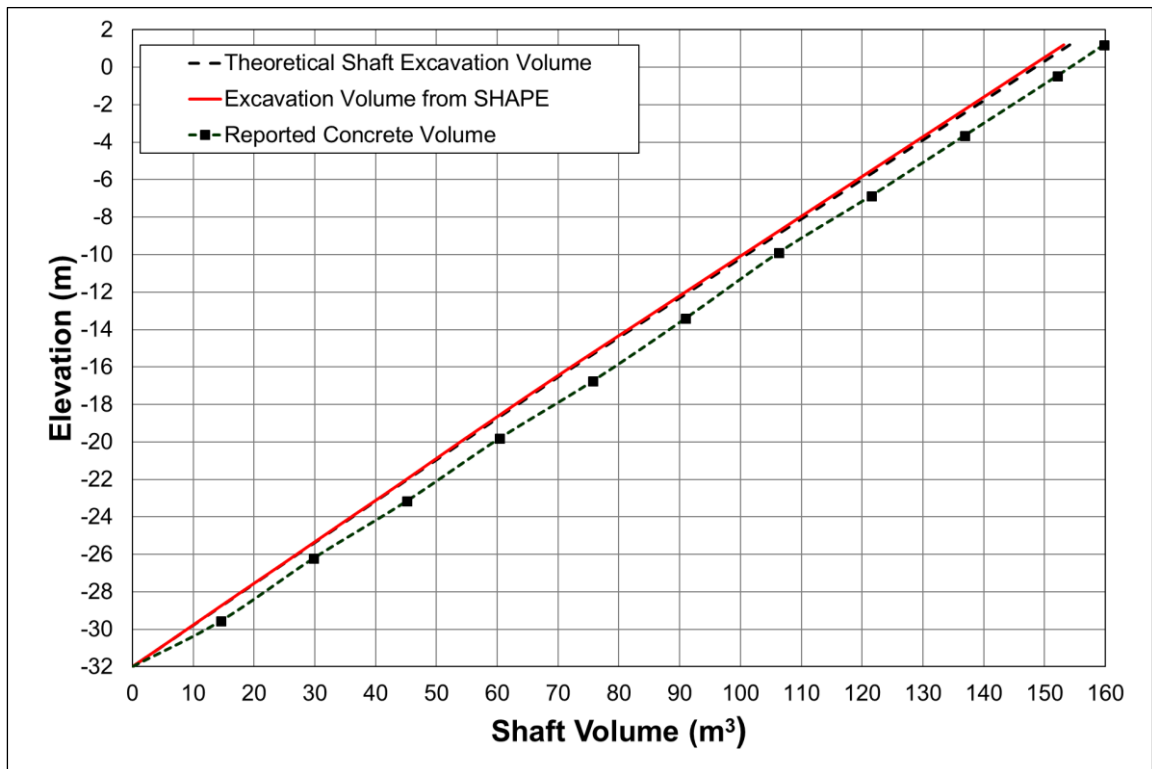
Figure 7. Comparison of Shaft Volumes Versus Elevation.

Figure 7 presents a plot of the placed concrete volume versus depth. This figure also includes the theoretical shaft excavation volume versus depth. SHAPE results of the excavated hole volume are also included in this figure. The SHAPE results closely mirror the theoretical volume which appears reasonable given that 58% of the shaft length was permanently cased. Construction concreting records indicate the placed volume was 104% of the theoretical volume. Based on the shaft construction techniques, this implies the extra concrete volume should be located in the lower uncased portion of the shaft.

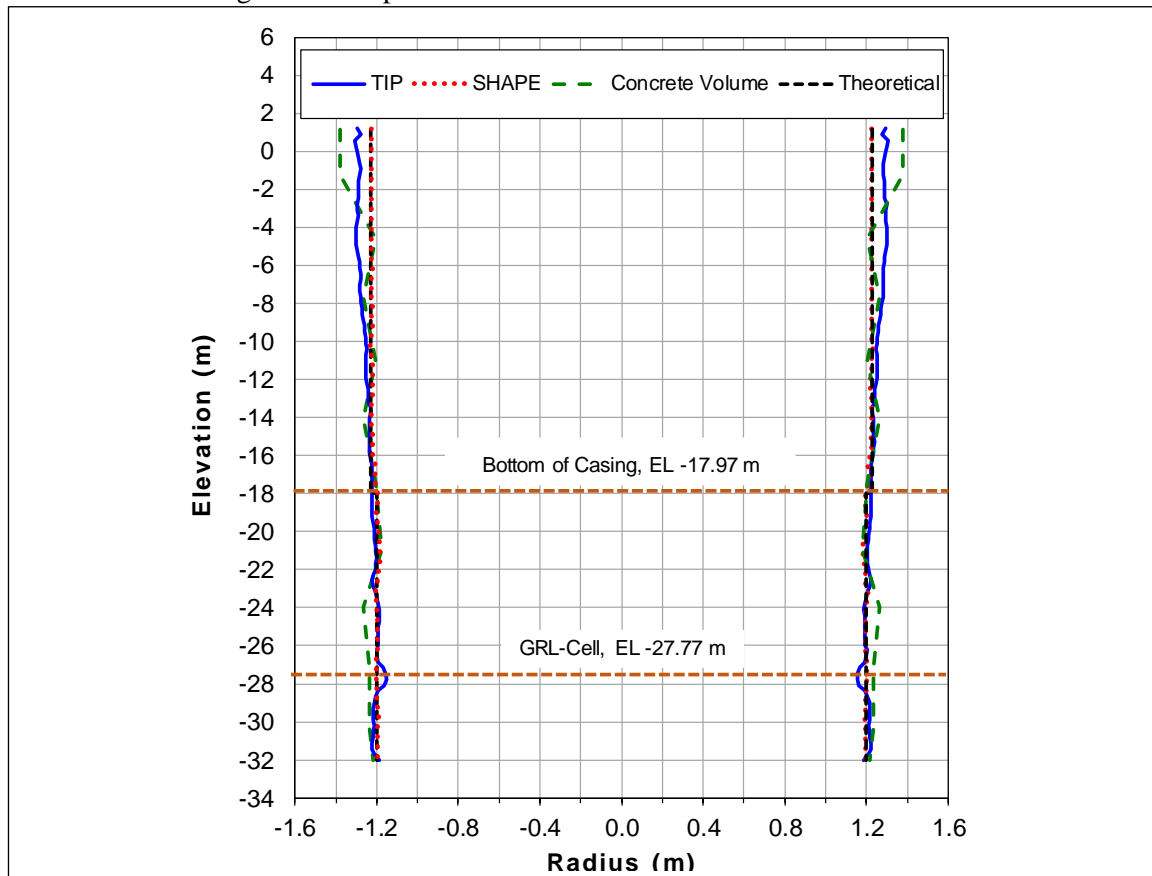
Figure 8. Comparison of Average Shaft Radius Versus Elevation.

The average radius and diameter of the constructed shaft was calculated from three methods; the placed concrete volume versus depth, the SHAPE results, and the thermal integrity profiling results. A comparison of the average shaft diameter from these methods as well as with the theoretical shaft diameter versus depth is presented in Figure 8.

The concrete volume information yields the largest shaft diameter below Elevation -22 m (-72 ft) in the uncased portion of the shaft. The concrete volume information also yields the largest shaft diameter above Elevation -4 m (-13 ft) in the permanently cased portion of the shaft which is unreasonable. The shaft diameter calculated by thermal integrity profiling clearly shows the bi-direction jack assembly at Elevation -27.7 m (91.0 ft) due to the heat sink associated with the steel cells at that location. Above Elevation -10.0 m (32.8 ft), the shaft diameter indicated by the thermal integrity profiling is slightly greater than the diameter of the

permanent casing. The shaft diameter calculated by SHAPE appears to be the most realistic representation of the constructed shaft.

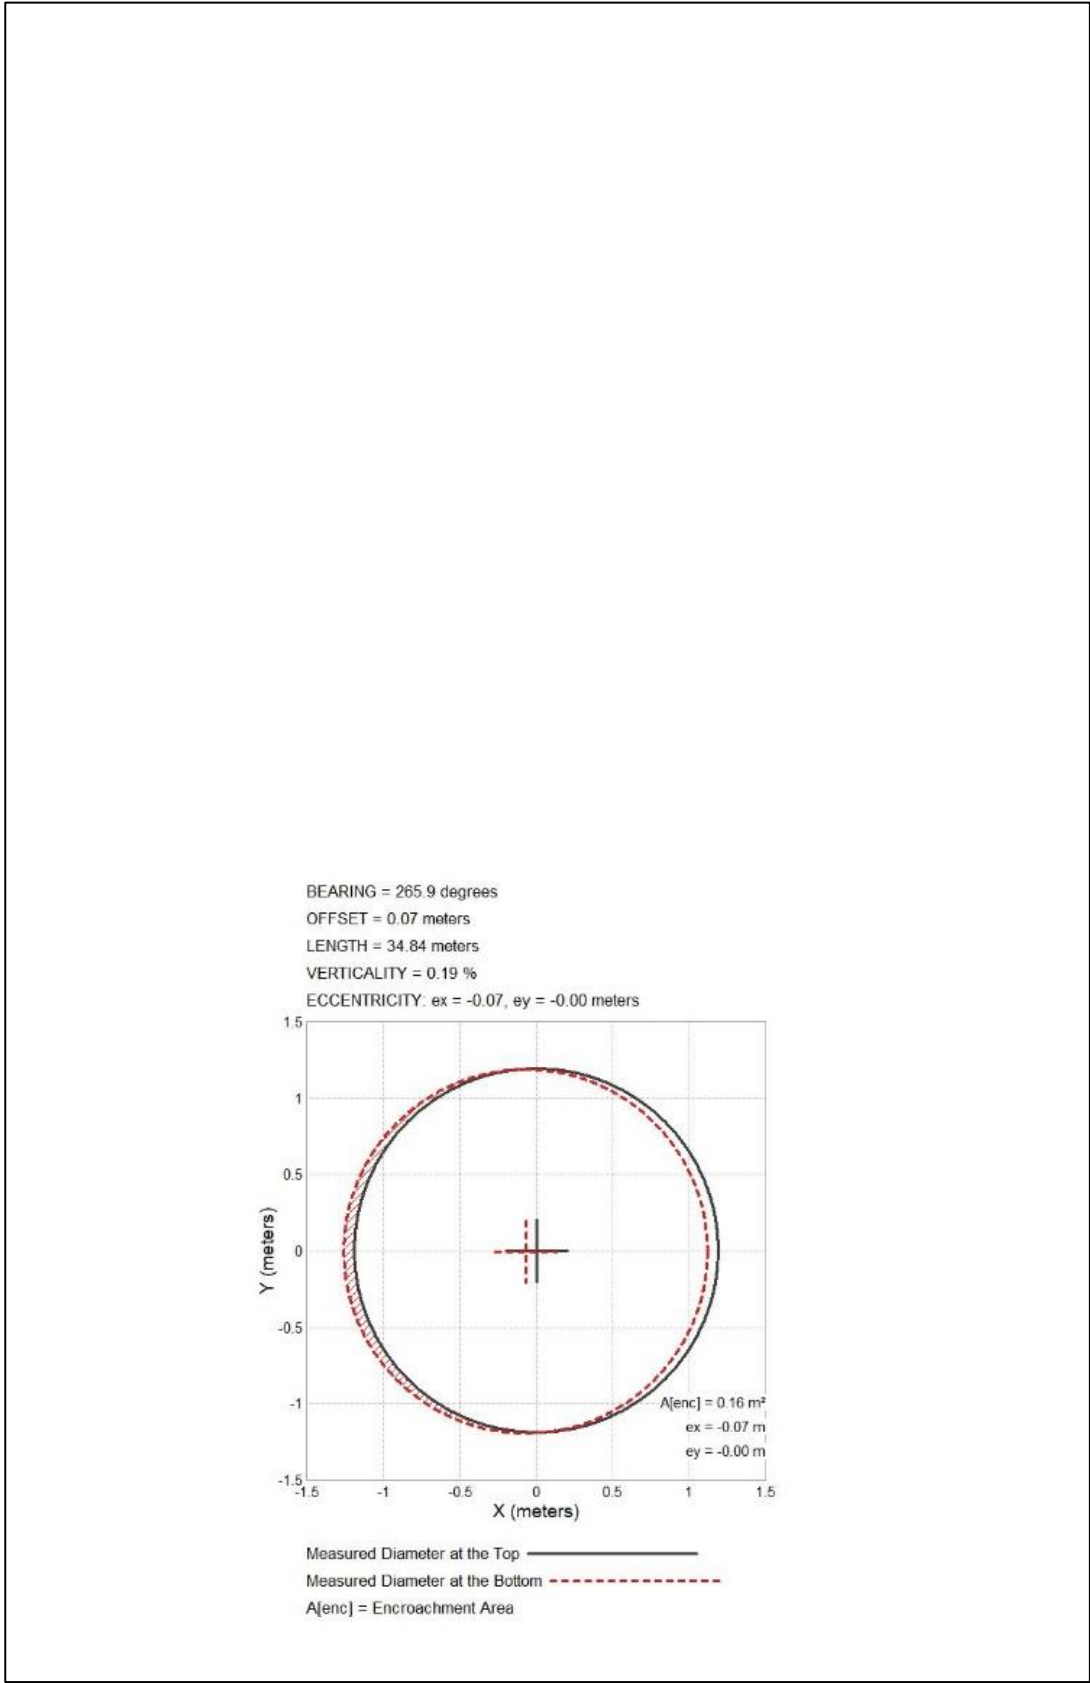
Figure 10. SHAPE Results of Shaft Radius Versus Depth.

As indicated in the profile schematic, sensor 1 is positioned to the north to conduct the test. The four scan profiles indicate the drilled shaft base drifts slightly towards the west. Figure 10 presents the SHAPE determined verticality and eccentricity. The verticality of 0.20% based on a base eccentricity of 0.07 m (0.23 ft) is well within the above noted specification limits. The lower portion of Figure 10 also displays the calculated encroachment area of 0.16 m² (1.72 ft²) into the shaft sidewall.

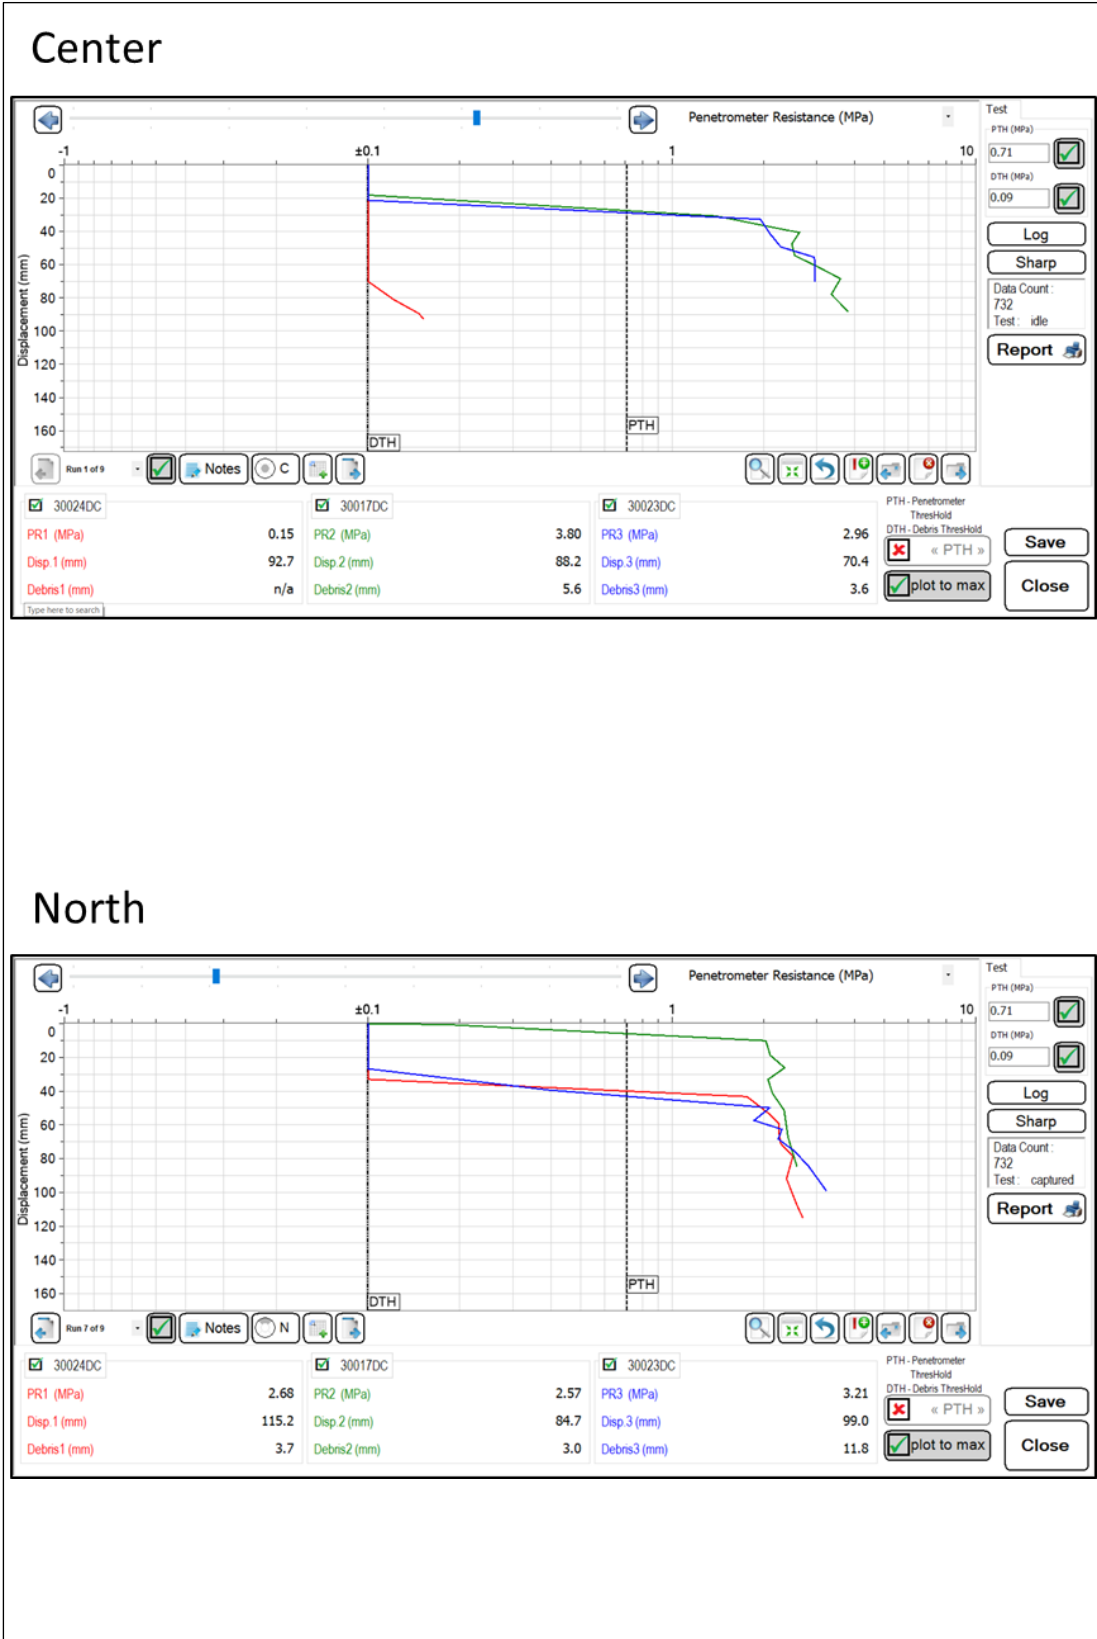
Figure 11. SQUID Results at Shaft Center and North Quadrant.

Figures 11 and 12 present the SQUID test results from four test locations; Center, North, East, and West. Since the primary purpose of the tests were to evaluate base cleanliness, the penetrometers were fitted with a flat tip rather than the conventional cone tip. Base cleanliness was assessed according to the criteria proposed by Moghaddam et al., (2017). The first vertical line, labeled DTH, is associated with penetration resistance associated with debris. Values less than DTH are associated with very soft materials that will be readily displaced or due to an uneven base condition causing a debris plate to hang atop a grooved or uneven surface. The second vertical line, labeled PTH, corresponds to the penetration resistance offered by natural soils. The measured displacement between crossing the DTH and PTH thresholds is the defined debris thickness.

The test results in Figures 11 and 12 indicate the debris thickness is typically on the order of 5 mm (0.2 in) or less across the test locations. Two of the eleven penetrometer locations had slightly greater debris thicknesses of 11.8 and 10.3 mm (0.5 and 0.4 in). However, the 13 mm (0.5 in) debris limit was not exceeded at any location. Therefore, less than 50% of the tested shaft base area had less than 13 mm (0.5 inches) of debris and no reading indicated more than the maximum allowed debris thickness at any location of 38 mm (1.5 in). Hence, the test shaft base was very clean.

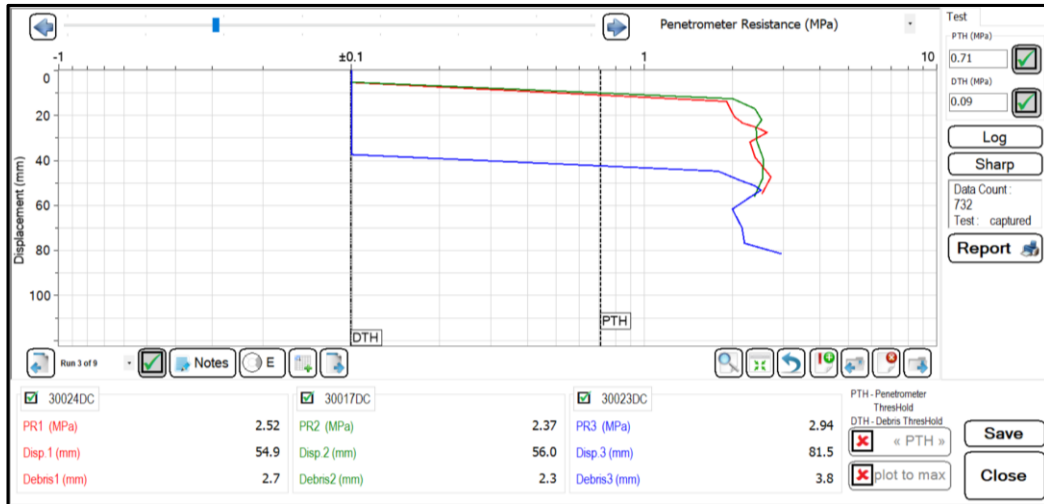
Figure 12. SQUID Results at East and West Quadrants.
