Pile Integrity Testing To Determine Storm-Induced Damage

WILLIAM CAMP AND MOHAMED HUSSEIN

Hurricane Hugo made landfall in 1989 near Charleston, South Carolina, causing extensive damage. A pleasure boat marina was exposed to the full force of the storm. The marina consisted of concrete floating docks held in place by 14-in.-square prestressed concrete piles. The 42-ft-long piles had been driven 2 years before, and installation records were not available at the time of the testing (1990). The water depth was between 2 and 10 ft, and the soil conditions consisted of approximately 10 ft of soft mud overlying the Cooper Marl. During the storm, the surge floated the docks to nearly the pile tops and the extraordinary winds and waves pushed the large pleasure boats against the piles. After the storm, it was observed that some piles could be moved several inches laterally simply by pushing on them while standing on the docks, thereby causing the pile integrity to be questioned. Short on time for the new season, the owner was faced with a serious problem with potentially expensive remedies. Low-strain integrity testing performed on each of the 78 piles provided a timely and cost-effective

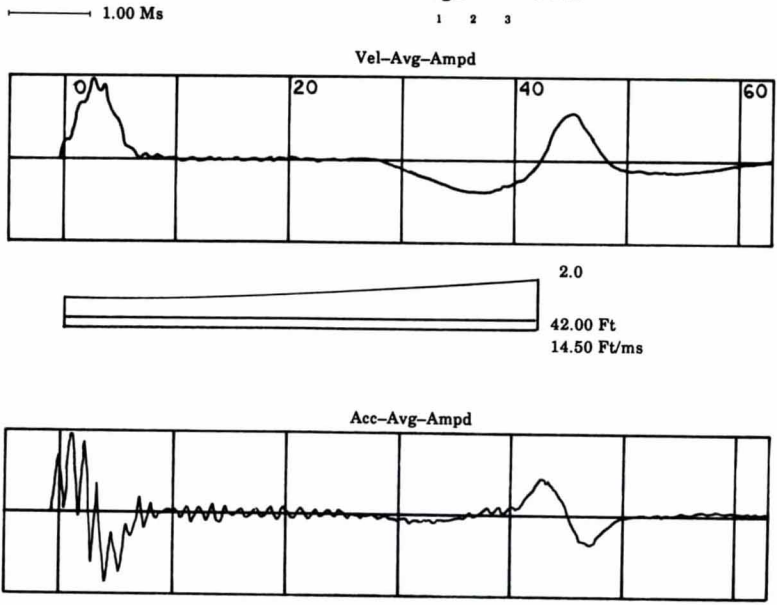
Typically, each test consisted of three or more hammer blows. Data from the blows were averaged, amplified, and plotted in the form of pile top velocity and acceleration as a function of pile length. A material stress wave speed of 14.6 ft/msec was used to convert from a time scale to a length scale. A typical result is shown in Figure 2; averaged and amplified pile top velocity and acceleration records are plotted on a length scale and superimposed pile length graphically depicting the applied data magnification.

FIGURE 2 Typical PIT results.
